PROJECT INSPECTION

Company	Helio	Type of Inspection:	SCC USE ONLY: General Contractor Review
Project	Arya	Date of Inspection	December 19, 2022
Inspector Name	Jeremy Chavez	Time of Inspection	08:35 AM

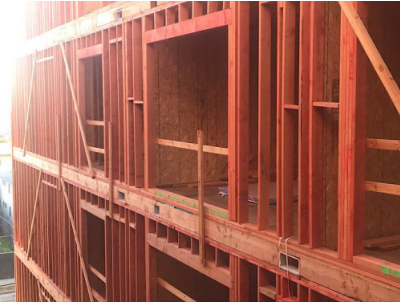
Cylinder Storage	N/A		-
Floor/Roof/Wall Openings	Satisfactory		-
Railing	Unsatisfactory	There are a few areas where railing is missing, or installed at an inadequate height. Please ensure railing is installed at 42-45" top rail with a mid rail halfway between the top rail and the working platform.

See railing comments.

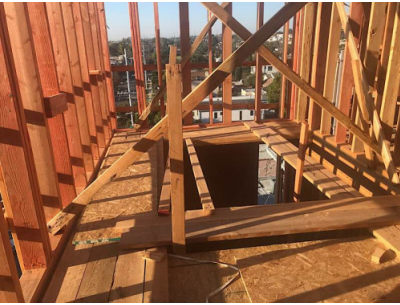
See railing comments.
