PROJECT INSPECTION

| Company | Helio | Type of Inspection: | SCC USE ONLY: General Contractor Review |
| Project | Arya | Date of Inspection | September 18, 2023 |

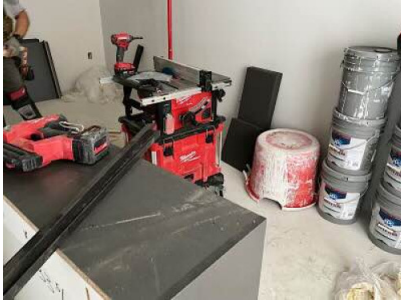
| Item | | Comment | Photo |
|---|---|---|---|
| Power Tools | Unsatisfactory | | - |

A table saw does not have its guard equipped. Please ensure tools have the manufacturers safety elements present and unaltered.

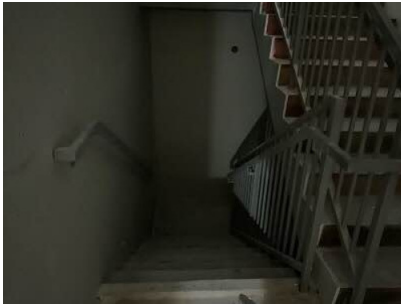
| Electrical Safety | Unsatisfactory | | - |

Insufficient illumination is in a stairway. Please ensure lighting is provided.

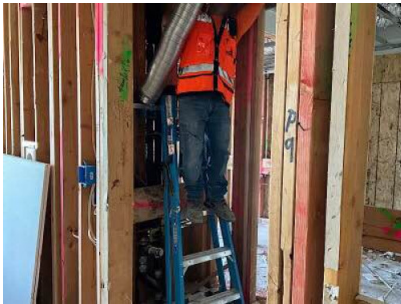
| Ladder Safety | Unsatisfactory | | - |

An employee is using an A-frame ladder in a closed position. Please ensure employees use ladders in an open, locked, and level position.

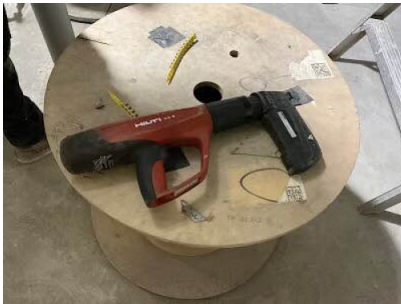
| Powder Actuated Tools | Unsatisfactory | | - |

A powder actuated tool has been left unattended and is not secured in a locked container. Please ensure cartridges are uploaded and the tool is kept in a locked container when not in use.

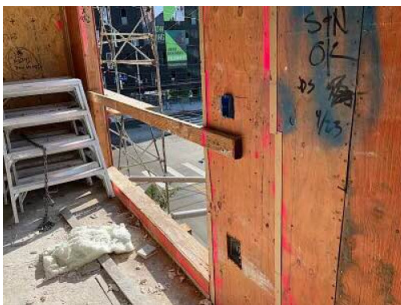
| Railing | Unsatisfactory | | - |

A missing guardrail exposed a fall hazard on the 3rd floor. Please ensure railing is installed.

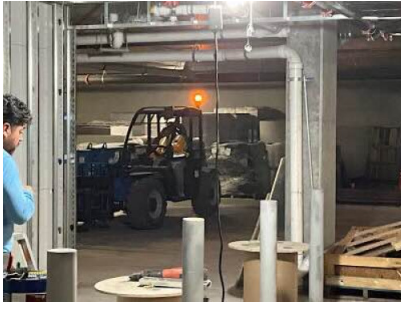
| Powered Industrial Trucks | Unsatisfactory | | - |

An employee is operating a rough terrain forklift while not wearing his seatbelt. Please ensure employees wear their seatbelt when required.
