PROJECT INSPECTION

Company	Helio	Type of Inspection:	SCC USE ONLY: General Contractor Review
Project	Canfield	Date of Inspection	January 08, 2024
Inspector Name	Jeremy Chavez	Time of Inspection	09:40 AM

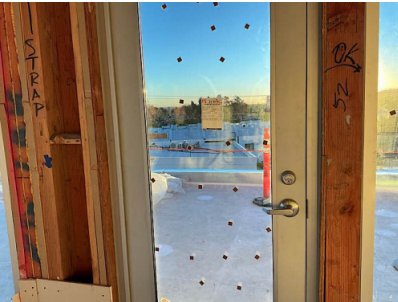
Danger tape is in use as a warning line on the roof, which is not permitted. Please ensure a warning line with the approved materials is installed. Signage should be posted indicating personal fall protection must be implemented when working beyond the door. The details were discussed with Chris Sandberg.
