PROJECT INSPECTION

Company	Helio	Type of Inspection:	SCC USE ONLY: General Contractor Review
Project	Canfield	Date of Inspection	October 17, 2022
Inspector Name	Jeremy Chavez	Time of Inspection	08:00 AM

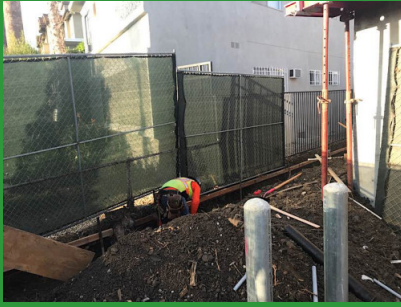
An employee was observed using a skill saw while not wearing safety glasses.

The employee complied to don ANSI rated safety glasses.

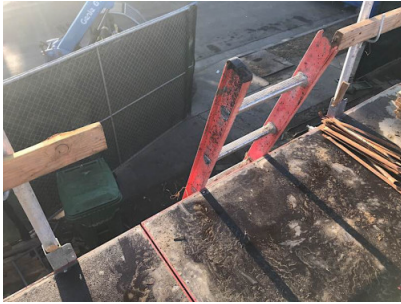
An access ladder does not reach the minimum 36" above the platform being accessed. Additionally, a removable guardrail has not been provided.

Electrical Safety	Satisfactory		-
Trenching/Excavation	N/A		-
Confined Space	N/A		-
Fall Protection	N/A		-
Ladder Safety	Unsatisfactory	Employees immediately raised the height of the access ladder. A removable guardrail will be installed.

Discussed with the superintendent the correction that will need to be made.

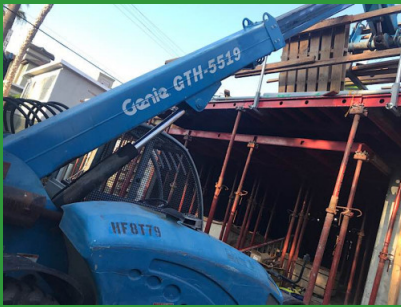
A reach lift has been left unattended while a load was raised.

The operator was found and instructed that he must be within 25' and line of sight of the reach lift while the forks are raised. The employee immediately complied.
