# PROJECT INSPECTION

<b>Company</b>	Helio	<b>Type of Inspection:</b>	SCC USE ONLY: General Contractor Review
<b>Project</b>	Canfield	<b>Date of Inspection</b>	October 03, 2022
<b>Inspector Name</b>	Jeremy Chavez	<b>Time of Inspection</b>	08:55 AM

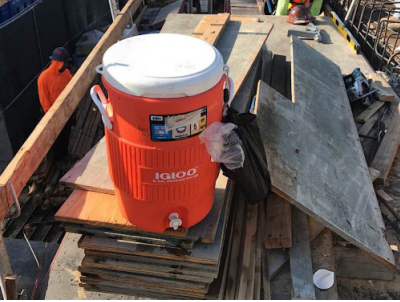
<p>Water container does not have individual cups and is in direct sunlight.</p>

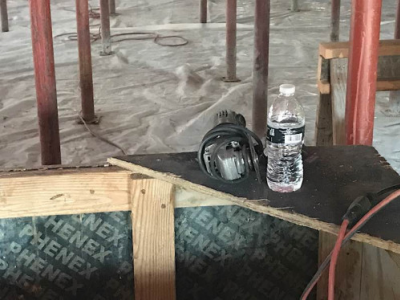
<p>An employee has a grinder that does not have its guard equipped.</p>	<p>The employee removed the grinder from the project and will ensure the guard is equipped prior to use.</p>

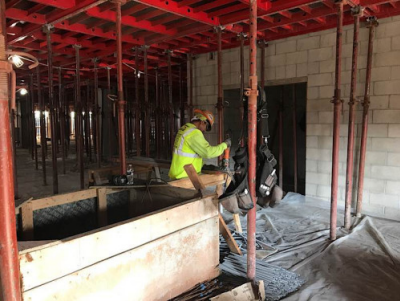
<p>An employee is using prescription glasses when ANSI rated safety glasses are required.</p>	<p>Please ensure employees wear ANSI rated safety glasses.</p>

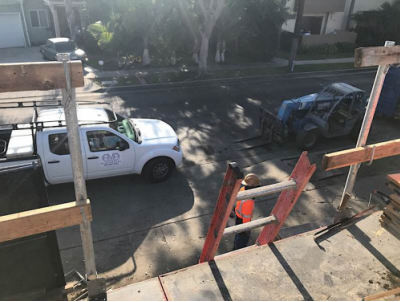
<p>The access ladder to the deck does not extend the required 36" above the platform being accessed. Additionally, a removable guardrail has not been installed.</p>	<p>Please ensure the access ladder is raised to the required height and a removable guardrail is installed.</p>
