PROJECT INSPECTION

Company	Helio	Type of Inspection:	SCC USE ONLY: General Contractor Review
Project	Canfield	Date of Inspection	November 01, 2022
Inspector Name	Jeremy Chavez	Time of Inspection	09:45 AM

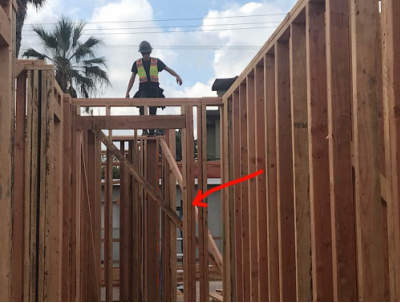
An employee used an A-Frame ladder to access the top of the studs.	Please ensure employees use an approved means of access, such as an extension ladder. The extension ladder must extend 36" above the platform being accessed, must be secured, and must be installed at a 4:1 height to distance ratio.

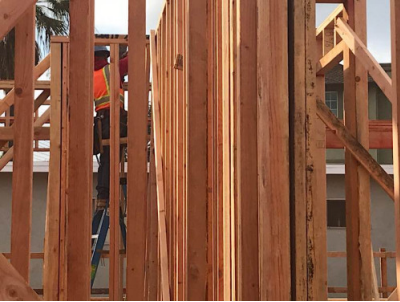
An employee is standing on the 2nd to top step of an A-Frame ladder, which is prohibited.	The employee complied to use only the approved steps.

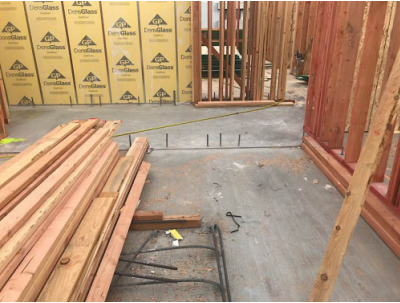
A few anchor bolts have not been capped.	Please ensure anchor bolts are capped or covered.
