PROJECT INSPECTION

Company	Helio	Type of Inspection:	SCC USE ONLY: General Contractor Review
Project	Canfield	Date of Inspection	August 01, 2022
Inspector Name	Jeremy Chavez	Time of Inspection	10:00 AM

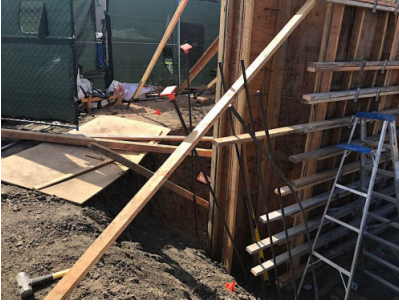
A few rebar caps were missing in the pictured area.

An employee was immediately assigned to make corrections. Rebar caps were installed.
