PROJECT INSPECTION

Company	Helio	Type of Inspection:	SCC USE ONLY: General Contractor Review
Project	Canfield	Date of Inspection	September 11, 2023
Inspector Name	Jeremy Chavez	Time of Inspection	12:08 PM

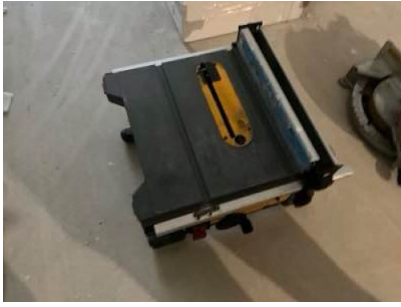
A table saw is not equipped with its guard. Please ensure tools have the manufacturers safety elements present and unaltered.

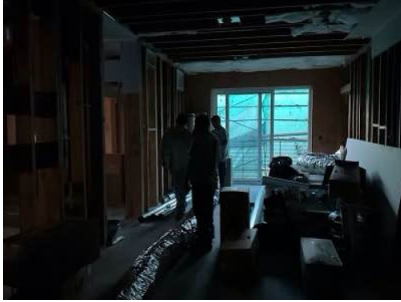
Several employees were not wearing the required PPE, which includes a hard hat and hi-vis vest or shirt. Please ensure employees wear the required PPE.

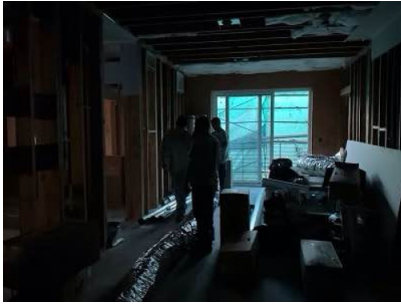
An area where employees are working is lacking the required illumination. Please provide lighting in work areas.

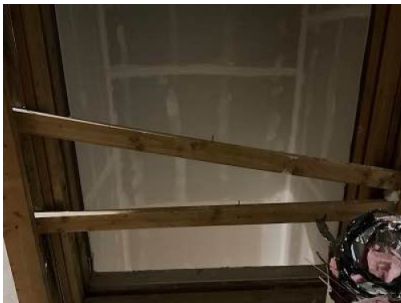
A guardrail appears to have been lowered and not reinstalled at the required height. Please ensure the top rail is installed, led at 42-45" height.

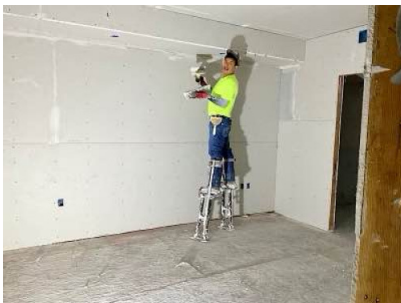
An employee is using stilts, which are prohibited. Please ensure employees use approved means of gaining elevation.

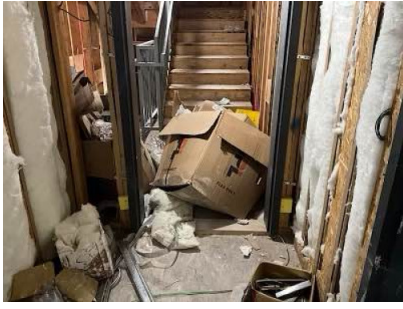
Housekeeping needs to give attention to debris and materials in walkways.
