PROJECT INSPECTION

Company	Helio	Type of Inspection:	SCC USE ONLY: General Contractor Review
Project	Canfield	Date of Inspection	September 19, 2022
Inspector Name	Jeremy Chavez	Time of Inspection	11:15 AM

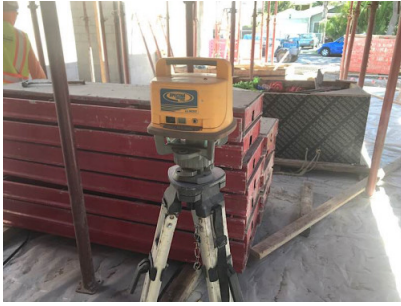
A laser has not been provided the required signage.

Please ensure a laser warning sign is posted.

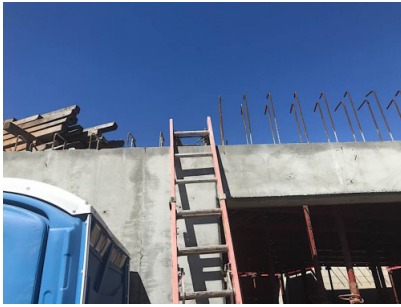
An access ladder installed does not extend the required 36" above the platform being accessed and is not secured.

Please ensure access ladders extend 36" above the platform being accessed and are secured from tipping, slipping, or falling.

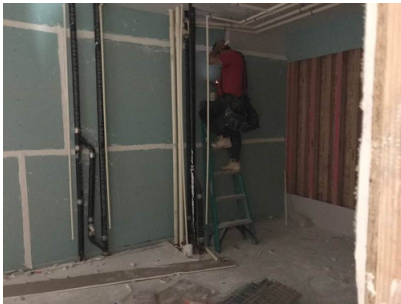
Employee is using an A-Frame ladder in a closed position.

Employees must use an A-Frame ladder in an open, locked, and level position.

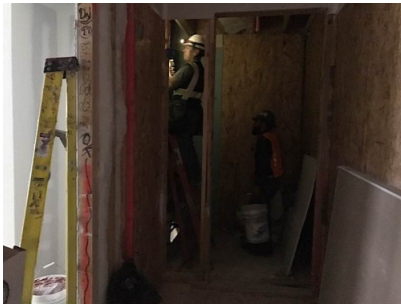
Employee is using an A-Frame ladder in a closed position.

Employees must use an A-Frame ladder in an open, locked, and level position.
