# PROJECT INSPECTION

<b>Company</b>	Helio	<b>Type of Inspection:</b>	SCC USE ONLY: General Contractor Review
<b>Project</b>	Canfield	<b>Date of Inspection</b>	September 05, 2023
<b>Inspector Name</b>	Jeremy Chavez	<b>Time of Inspection</b>	01:06 PM

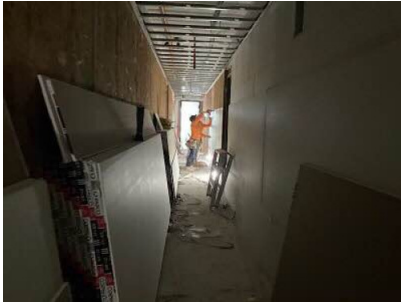
Several employees were observed not wearing the required PPE, such as a hard hat. Please ensure employees wear their PPE

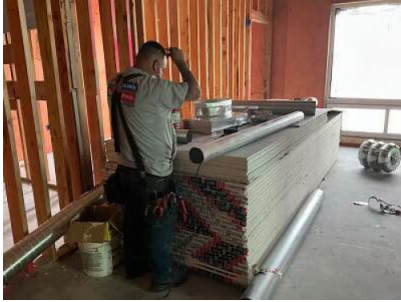
An employee was observed cutting an aluminum pipe with a grinder while not wearing a face shield. Please ensure employees are wearing the proper PPE.

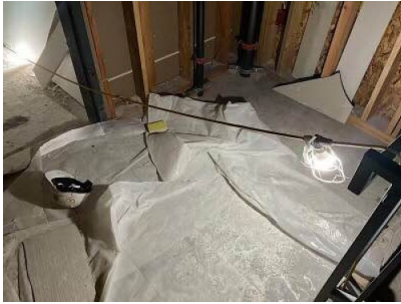
String lights are running across a walkway. Please ensure the lights are raised.

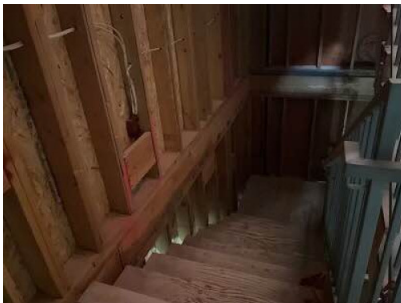
There continues to be insufficient illumination in a stairwell. Please ensure lighting is provided.

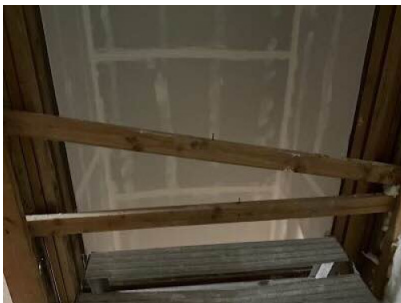
A guardrail appears to have been lowered and not reinstalled at the required height. Please ensure that the top rail is installed at 42-45" in height.
