PROJECT INSPECTION

Company	Helio	Type of Inspection:	SCC USE ONLY: General Contractor Review
Project	Venue	Date of Inspection	October 28, 2021
Inspector Name	Jeremy Chavez	Time of Inspection	10:03 AM

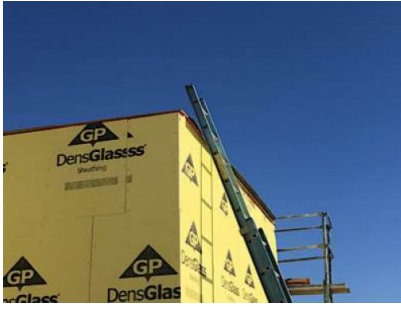
Ladder does not extend 36" above the platform being accessed and it is not secured from tipping.

The ladder height was raised and it will be held when in use.

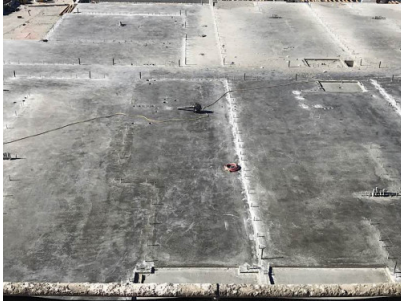
Anchor bolts are not capped or covered.

This was discussed with the superintendent and will be corrected as soon as possible.
