PROJECT INSPECTION

Company	Helio	Type of Inspection:	SCC USE ONLY: General Contractor Review
Project	Venue	Date of Inspection	December 20, 2021
Inspector Name	Jeremy Chavez	Time of Inspection	12:08 PM

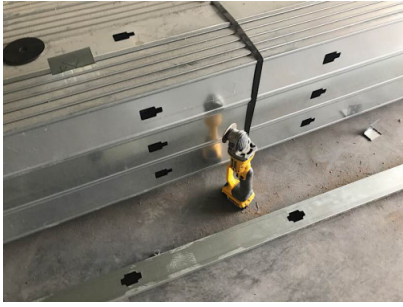
Grinder has its guard removed.

Please ensure tools have the manufacturer's guard present.

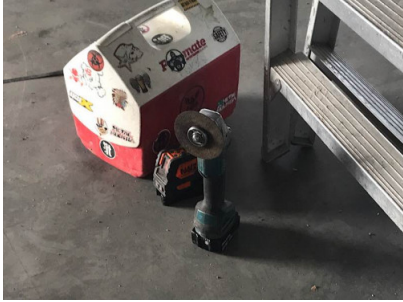
Grinder has its guard removed.

Please ensure tools have the manufacturer's guard present.

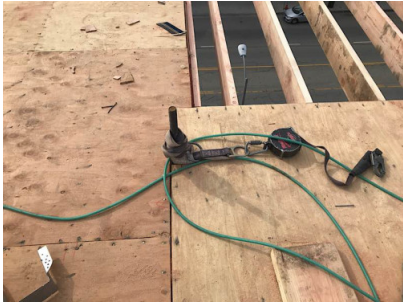
The beam strap is tied around a tie rod.

Discussed with the employee the correct method of installing a beam strap. As a general reminder, please ensure employees have been trained in Fall Protection.

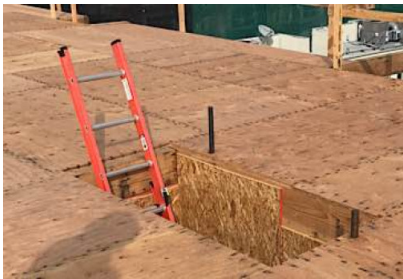
This access ladder creates an opening.

Please ensure a corral is installed.

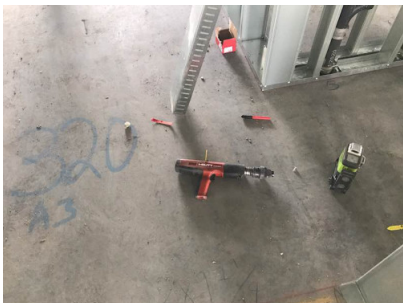
Employee is using a PAT and does not have his certification card on him. Additionally, warning signs must be posted.

Please ensure employees using PAT's have a current certification and signage is posted.
