PROJECT INSPECTION

Company	Helio	Type of Inspection:	SCC USE ONLY: General Contractor Review
Project	Venue	Date of Inspection	May 10, 2022
Inspector Name	Jeremy Chavez	Time of Inspection	09:10 AM

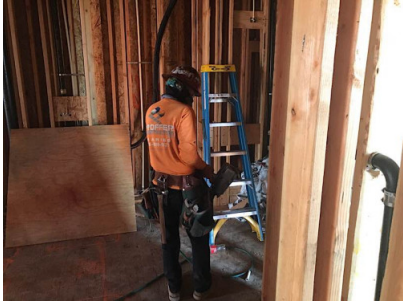
<p>Employee was observed using an A-Frame ladder in a closed position.</p>	<p>The employee immediately complied to use his ladder in an open, locked, and level position. On a positive note, he was wearing the required PPE, including safety glasses.</p>

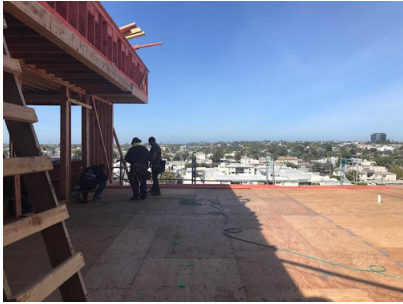
<p>Employees are working above their trigger height while inadequate railing is provided. The scaffold does not have the required guardrails installed and the top tie anchor is not secured within a 3:1 height to width ratio from the top of the scaffold.</p>	<p>Discussed with the foreman and the superintendent providing the required railing while the parapet wall is constructed. Railing will be installed shortly.</p>

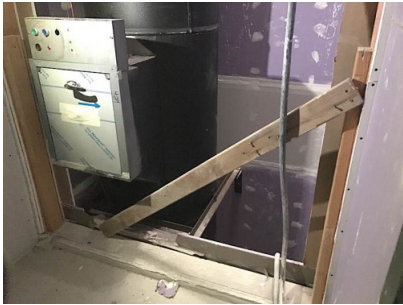
<p>A trash chute was installed yesterday. Existing railing was removed, creating a fall hazard.</p>	<p>Discussed with the superintendent a method of installing railing for a few of these openings on a couple of levels.</p>
