PROJECT INSPECTION

Company	Helio	Type of Inspection:	SCC USE ONLY: General Contractor Review
Project	Venue	Date of Inspection	May 16, 2022
Inspector Name	Jeremy Chavez	Time of Inspection	11:15 AM

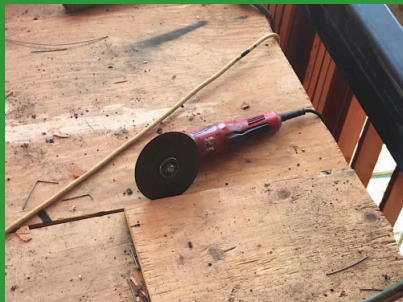
This grinder does not have its guard equipped.

Please ensure a larger grinder is used for the size of cutting wheel that is needed. This will allow for the guard to be equipped.

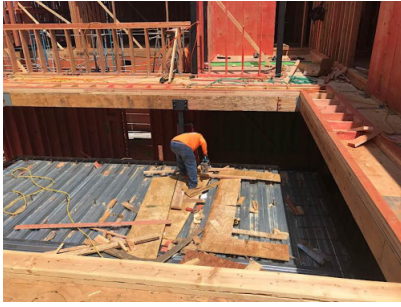
Employee is not wearing safety glasses while using a skill saw.

Employees must wear ANSI Z87 safety glasses when using power tools that create flying particles.

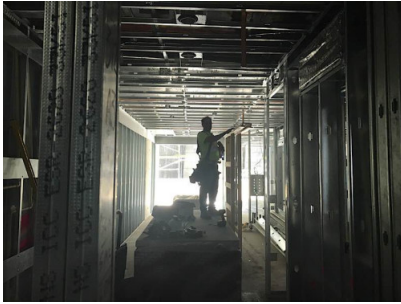
Employee is using a nail gun while not wearing safety glasses.

Employees must wear ANSI Z87 safety glasses when using power tools that create flying particles.

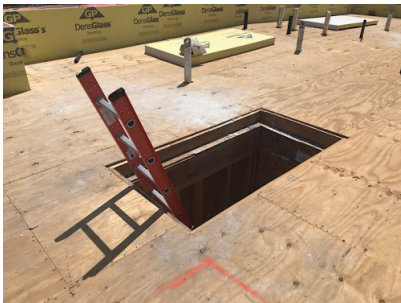
This access ladder does not have a corral, which creates an opening.

The superintendent reported stairs are scheduled to be completed to the roof tomorrow and the ladder will be removed. The opening will then be covered.

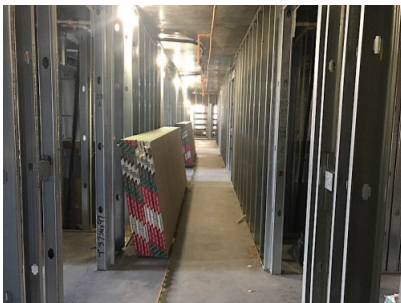
Drywall that is stacked vertically against a wall is not secured.

Please ensure materials such as drywall and plywood that is stacked vertically against a wall is secured from tipping, slipping, or falling.

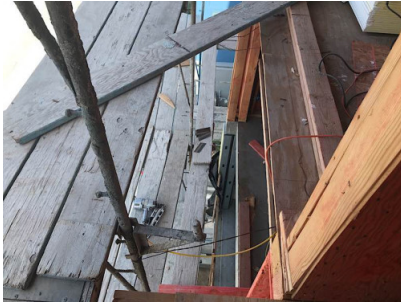
Proffer employees are using a section of scaffolding that is missing the required planks and railing.

Scaffolding must be fully planked. One of the outrigger braces is missing, which in turn does not allow for a plank to be installed. Also, in areas where scaffolding exceeds 16" from the structure, railing on the scaffold and structure must be provided. Employees discontinued work in this area and the scaffold sub contractor was contacted.
