PROJECT INSPECTION

Company	Helio	Type of Inspection:	SCC USE ONLY: General Contractor Review
Project	Venue	Date of Inspection	May 23, 2022
Inspector Name	Jeremy Chavez	Time of Inspection	11:00 AM

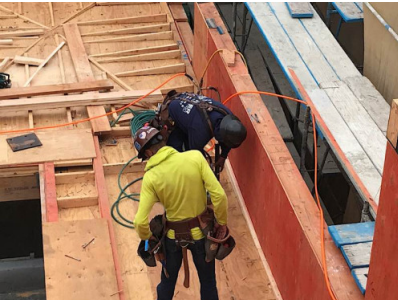
Employee is using a nail gun while not wearing safety glasses.	The employee immediately complied to wear his safety glasses.

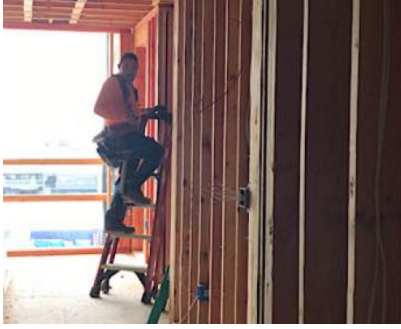
Employee is using an A-Frame ladder in a closed position.

Employee complied to use the ladder in an open, locked, and level position.

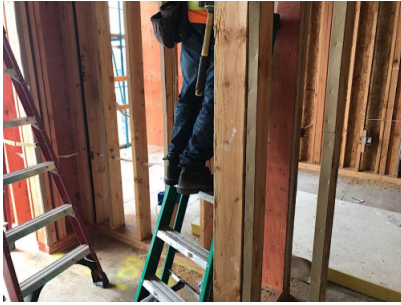
Employee is using an A-Frame ladder in a closed position.

Employee complied to use the ladder in an open, locked, and level position.

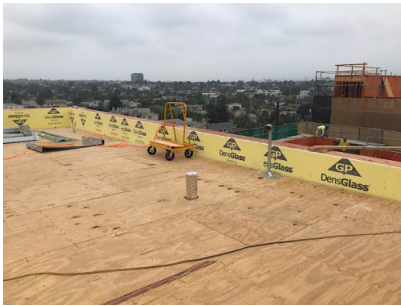
Permanent railing is being fabricated, which leaves a low parapet wall and fall hazard.

Discussed providing a warning line for the roof. This is due to distance not being an accepted method of fall protection.

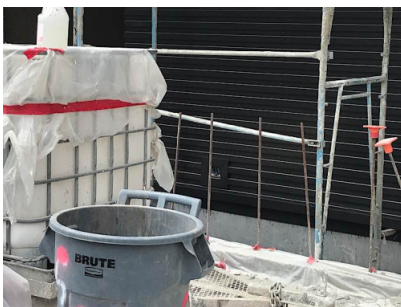
Rebar is not capped or covered. It appears the caps were dislodged.

The superintendent assigned an employee to reinstall the rebar caps.
