# PROJECT INSPECTION

<b>Company</b>	Helio	<b>Type of Inspection:</b>	SCC USE ONLY: General Contractor Review
<b>Project</b>	Venue	<b>Date of Inspection</b>	May 04, 2021
<b>Inspector Name</b>	Jeremy Chavez	<b>Time of Inspection</b>	09:40 AM

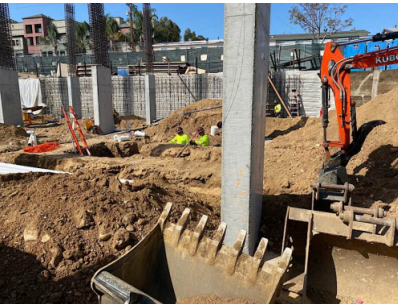
Employees are working within 6' of each other while not wearing a face covering.	A face covering was put on.

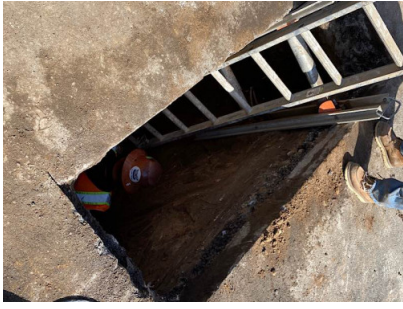
Employee was working in a trench deeper than 4' while a ladder was not in the trench.

As pictured, an access ladder was setup.

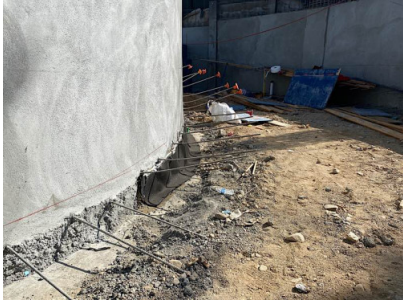
Rebar in an area is uncapped.

Employees began capping the rebar.
