# PROJECT INSPECTION

<b>Company</b>	Helio	<b>Type of Inspection:</b>	SCC USE ONLY: General Contractor Review
<b>Project</b>	Venue	<b>Date of Inspection</b>	August 17, 2022
<b>Inspector Name</b>	Jeremy Chavez	<b>Time of Inspection</b>	08:30 AM

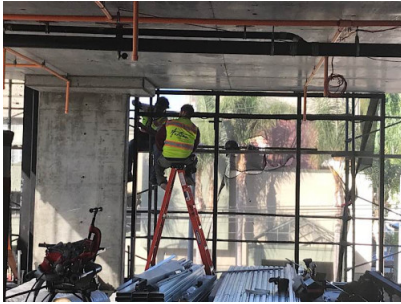
Employee is straddling an A-Frame ladder, which is prohibited.

Employee complied to stand on the approved steps and only use one side of the ladder.

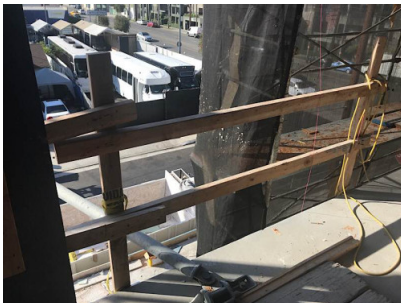
A set of railing was observed to be below the required height. The height measured was 38".

Please ensure railing is installed at 42-45" top rail, with a mid rail halfway between the top rail and the working platform. The superintendent immediately assigned an employee to begin making corrections. As a note, personal fall protection must be implemented while installing the updated railing.

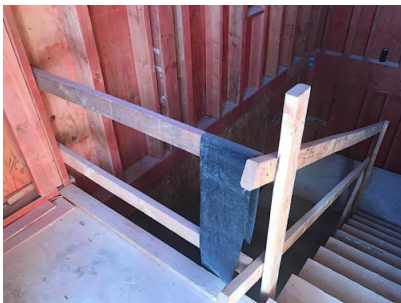
Another set of railing was observed to be below the required height. This set of guardrails was located on the roof level.

Please ensure railing is installed at 42-45" top rail, with a mid rail halfway between the top rail and the working platform. The superintendent immediately assigned an employee to begin making corrections.

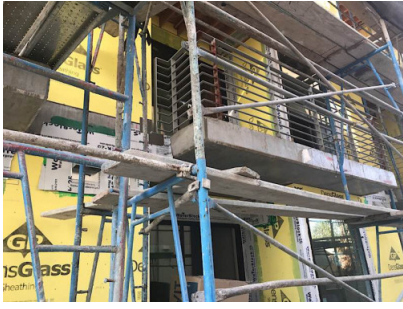
A section of scaffolding is missing the required planks.

The superintendent will be contacting the scaffold contractor to ensure the required planks are provided. In the meantime this section of scaffold will be red tagged to indicate that it is out of service.
