PROJECT INSPECTION

Company	Helio	Type of Inspection:	SCC USE ONLY: General Contractor Review
Project	Venue	Date of Inspection	August 24, 2021
Inspector Name	Jeremy Chavez	Time of Inspection	07:00 AM

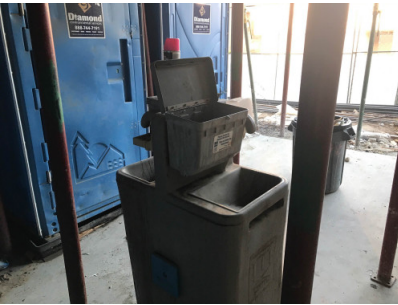
Wash station does not have soap or disposable towels.	The superintendent reported the restrooms and wash stations will be serviced today.

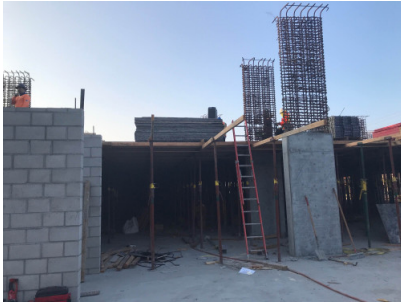
Access ladder does not extend the required 36" above the platform being accessed.

The ladder was raised the required height.

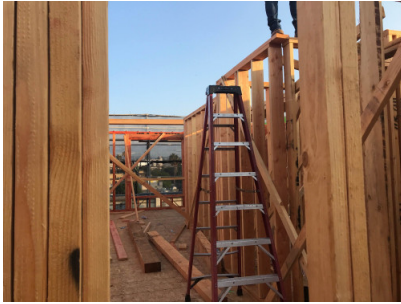
An A-Frame ladder is being used as an access ladder.

Please ensure an extension ladder is installed.

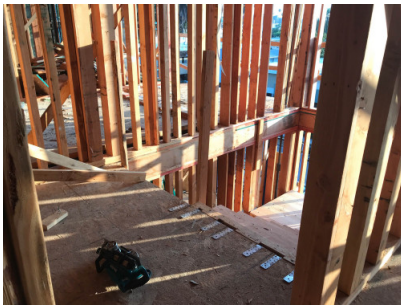
A second set of stairs to the top floor of building are reported to be completed by days end.

See above.

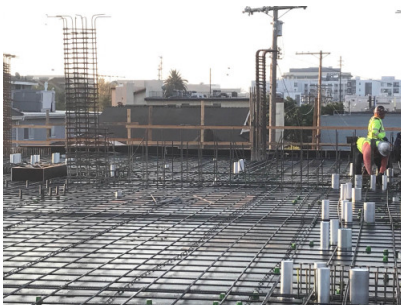
A few areas did not have the required rebar caps.

Employees were assigned to make corrections.
