PROJECT INSPECTION

Company	Helio	Type of Inspection:	SCC USE ONLY: General Contractor Review
Project	Venue	Date of Inspection	August 30, 2021
Inspector Name	Jeremy Chavez	Time of Inspection	11:20 AM

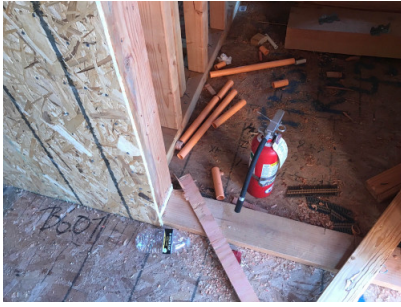
Sheathing was just installed and brackets holding the fire extinguisher were removed.

The brackets will be reinstalled soon.

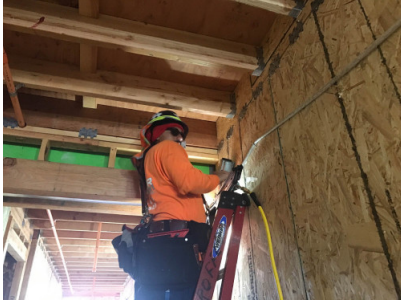
Employee is operating a nail gun while wearing sunglasses.

Discussed using ANSI Z87+ safety glasses.

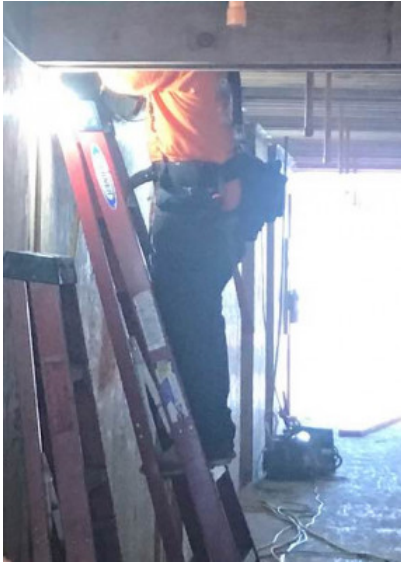
Employee is using an A-Frame ladder in a closed position.

Employee complied to use the ladder in an open, locked, and level position.

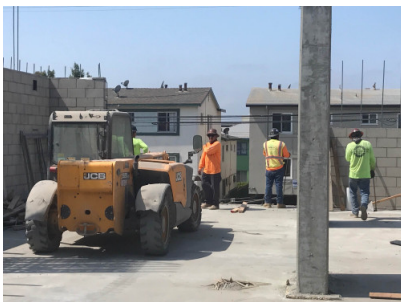
Guardrails have been removed in this loading/unloading zone.

Discussed methods of fall protection while loading/unloading material.

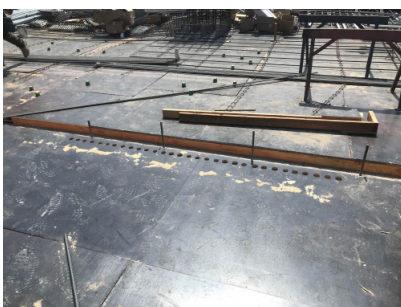
Rebar must be capped.

Ensure caps are installed.

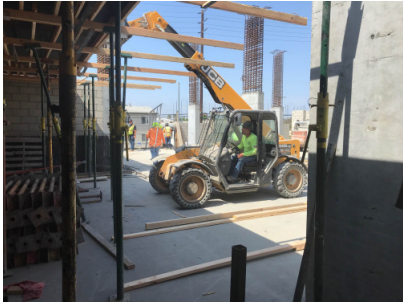
Employee is operating a reach lift while not wearing his seatbelt.

Please ensure employees wear their seatbelt when operating equipment.
