PROJECT INSPECTION

Company	Helio	Type of Inspection:	SCC USE ONLY: General Contractor Review
Project	Venue	Date of Inspection	September 09, 2021
Inspector Name	Jeremy Chavez	Time of Inspection	09:40 AM

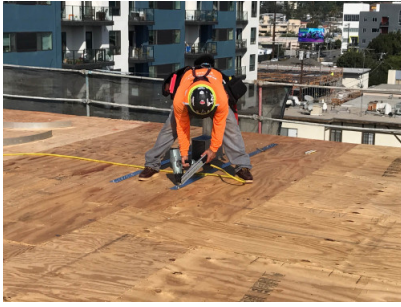
Employee is using a nail gun while wearing sunglasses that are not ANSI rated.

Safety glasses were donned.

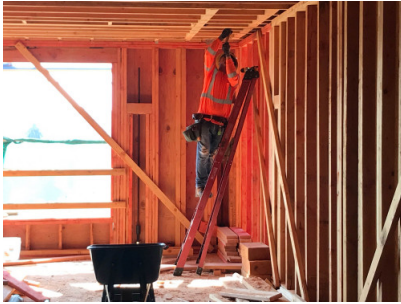
Employee is using an A-Frame ladder in a closed position.

Please ensure A-Frame ladders are used in an open, locked, and level position.

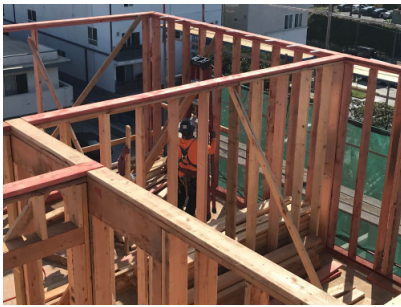
Employee was observed using an A-Frame ladder in a closed position.

Please ensure A-Frame ladders are used in an open, locked, and level position.

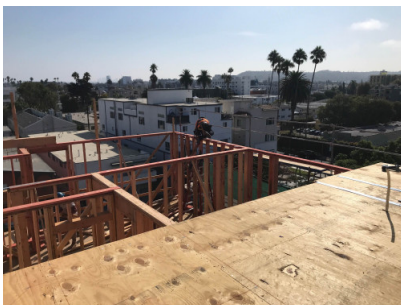
Employee stood on the top 2 steps of an A-Frame ladder to gain access to the scaffold.

Please ensure approved access ladders are used for scaffold access.

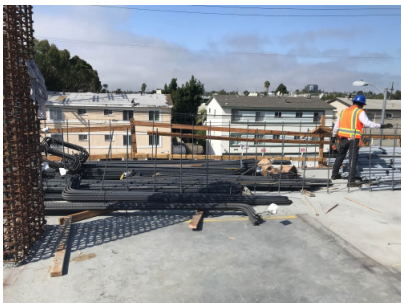
Rebar caps are missing.

Please ensure rebar caps are installed.

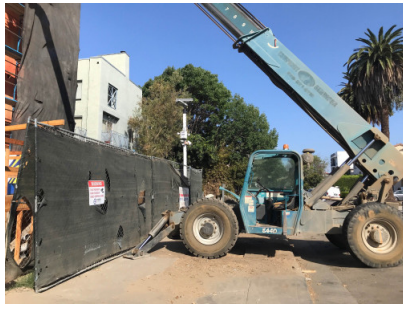
A reach lift is unattended while a load is lifted.

Please ensure the operator is within 25' and line of sight while the load is lifted.
