PROJECT INSPECTION

| Company | Positive Electric Co. | Type of Inspection: | Job Progress Inspection |
| Project | Summit Fire House | Date of Inspection | February 02, 2024 |

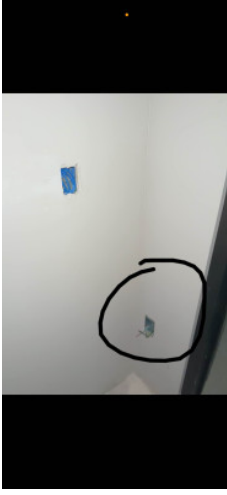
| Item | | Comment | Photo |
|---|---|---|---|
| Was work completed? | Satisfactory | Tomas finished moving the 4 outlets that were originally located in a glass wall. (Ckt L5-38 admin lobby and conferee room) | |
