# PROJECT INSPECTION

| <b>Company</b> | ABC & Co. | <b>Type of Inspection:</b> | Roofing Inspection |
| <b>Project</b> | Project 2 Test | <b>Date Of Incident</b> | June 18, 2018 |

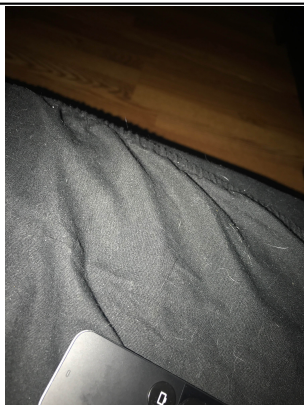
| Item | | Comment |
|--|---|---|
| Tools & equipment are being used safely | Unsatisfactory | This is not very good |

| Photo | Comment | Corrective Action |
|--|---|---|
| | Trying this out | |
