# PROJECT INSPECTION

<b>Company</b>	ABC & Co.	<b>Type of Inspection:</b>	Trenching & Excavation Inspection
<b>Project</b>	Project 3 Test	<b>Date Of Incident</b>	June 17, 2018
<b>Inspector Name</b>	user@gmail.com	<b>Time Of Incident</b>	01:20 AM

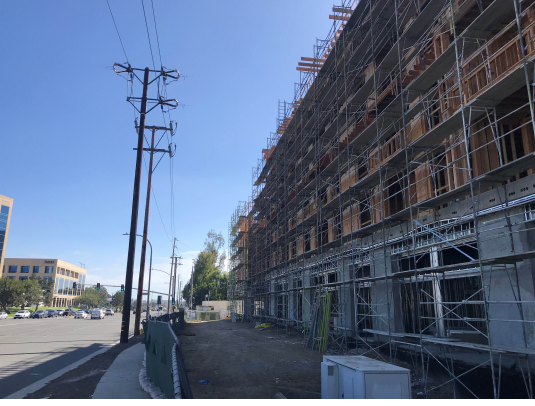
Item		Comment
OSHA permit is present	Satisfactory	Nuuhuunuuhj
Is a protective system in place for the trench if 5' or deeper?	Satisfactory	
Are spoils at least 2' back from the top of the trench?	Unsatisfactory

Jjjijomom	
-	Okmiomomo
