SAFETY INSPECTION REPORT

PROJECT:
Scarlati Place Remodel

INSPECTION TYPE:
General Construction

INSPECTOR : JORDAN DELOYE
DATE : NOVEMBER 26, 2024
CITY : LA JOLLA
STATE : CA

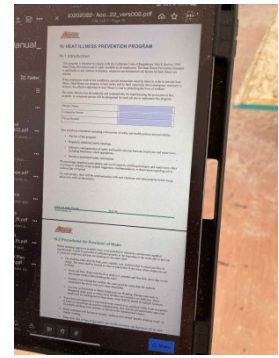
Heat Illness Prevention Program is available and site specific information is completed.

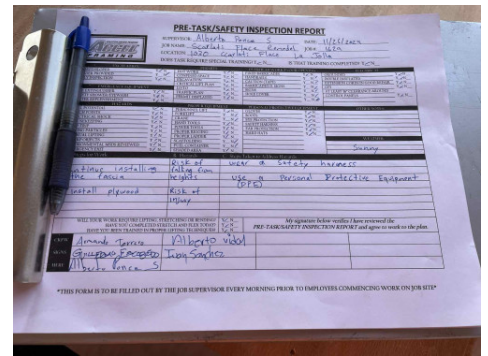
Daily Inspections

Daily inspections are being performed

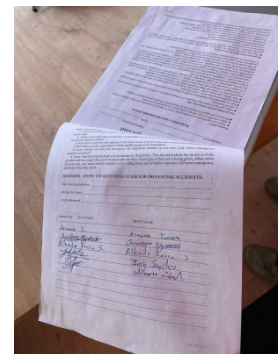
Tailgate Meetings

Tailgates are being conducted at least every 10 working days

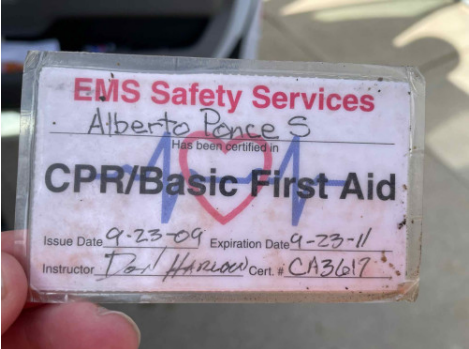
First Aid / CPR Certification		Unsatisfactory
Comment		
Alberto has a certification but it is out of date

Fire extinguisher inspection and CPR cert both need to be updated

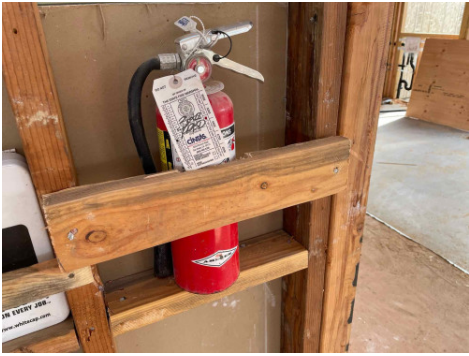
Fire Extinguisher(s)	Unsatisfactory
Comment

Fire extinguisher is not current and not up-to-date

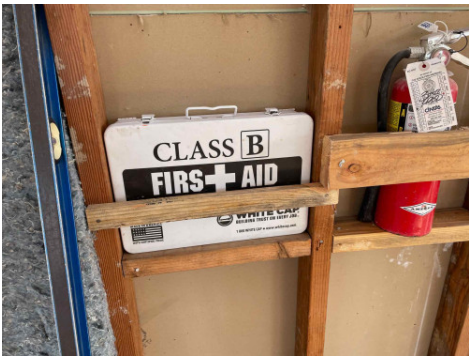
First aid kit is available in front room.

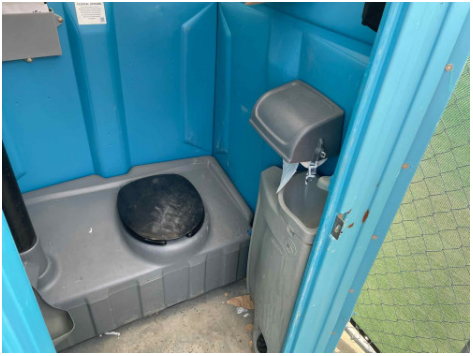
Plenty of toilets are located on site and are being kept clean and in good working order.

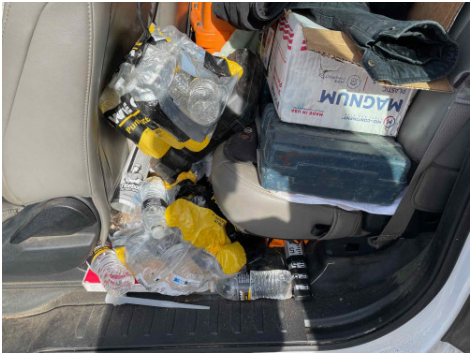
Water is available in his truck

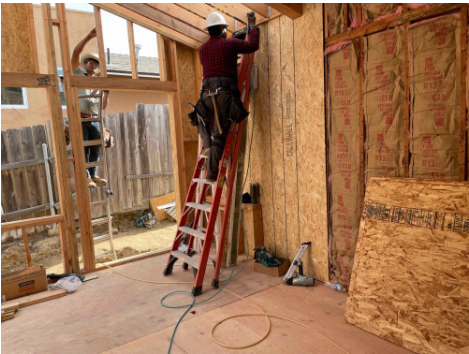
Ladders	Unsatisfactory
----------------	-----------------------

Comment	
Had to remind one of the workers not to use an A frame ladder leaned up against a wall like this. Please continue to make sure Ladders are used properly.

Ladders need to be used correctly.

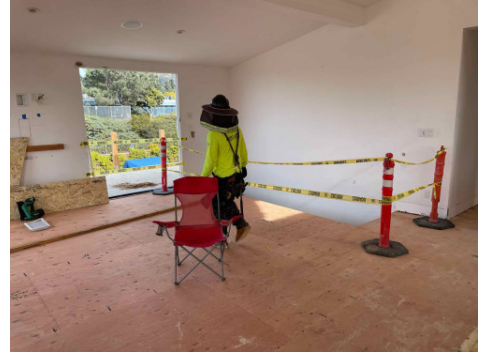
Fall Protection	Satisfactory
------------------------	---------------------

Delineators and caution tape are placed around open stairwell, please ensure that delineation lines are set 6' back from the leading edge.

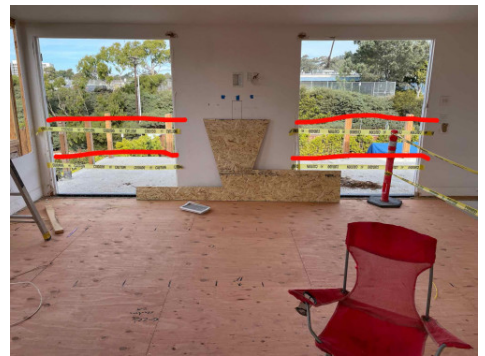
Guardrails need to have the top rail installed at 42-45" and a mid-rail at half the height of the top rail. Upright supports are needed every 8 feet.

Guard rails need to be placed in front of doors that lead out to an unprotected balcony.
