# SAFETY INSPECTION REPORT

Terra Campagna (Somis Phase II)

General Construction

**DATE :** AUGUST 12, 2024

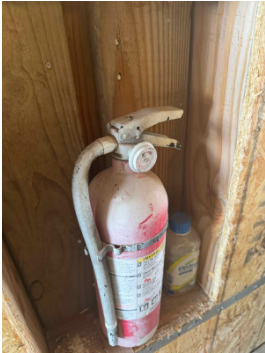
<b>Fire Extinguisher(s)</b>		<b>Unsatisfactory</b>
<b>Comment</b>		
There is no pin in the fire extinguisher. Building 27.

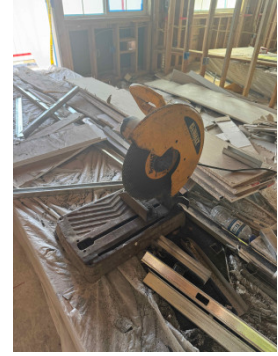
Cauldron employee had a chop saw with guard in place. Additionally, there should be a spark guard behind the saw to catch the sparks.

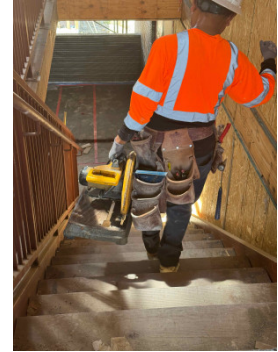
Removed on the spot.

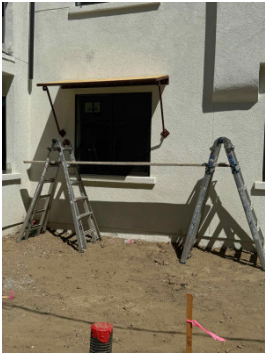
<p>Larrabure framing has 2 ladders set up with a plank in between them. This can not be done. Ant platforms need at least 2 planks.</p>

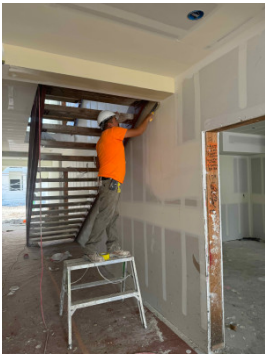
<p>Taping and drywalling was seen being done safely. Good job.</p>

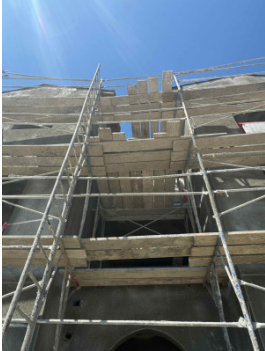
<b>Comment</b>	
Building 27 - Stucco was recently set and corrections need to be made to the scaffolding. Toe boards need to be placed above exit/entry ways.

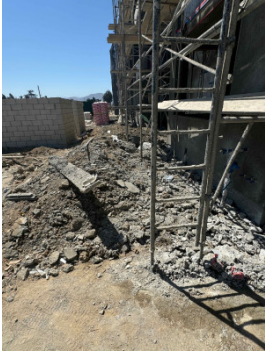
Debris will be cleaned up.

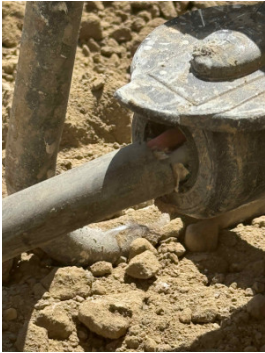
Comment	
240V cable is damaged and needs to be replaced. Next to the building 25. This is being fixed on the spot.
