# SAFETY INSPECTION REPORT

**CONDUCTED FOR:**  
FCB Homes

**PROJECT:**  
Gateway South

**INSPECTION TYPE:**  
General Construction

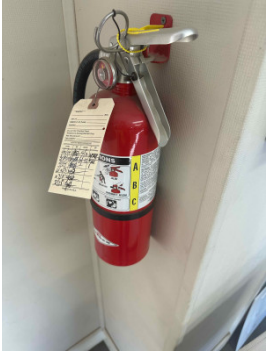
<b>Fire Extinguisher(s)</b>	<b>Satisfactory</b>
<b>Comment</b>

<p>Fire extinguishers were found in satisfactory condition. Extinguishers are being inspected and documented monthly.</p>

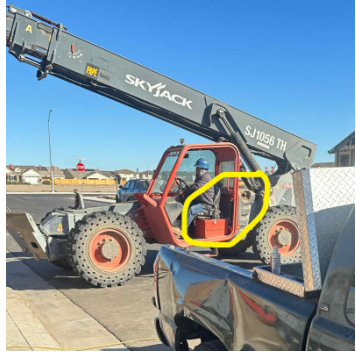
<b>Powered Industrial Trucks</b>	<b>Unsatisfactory</b>
<b>Comment</b>

<p>Reach lift operator was reminded to wear seatbelt when operating equipment. (corrected on the spot.)</p>

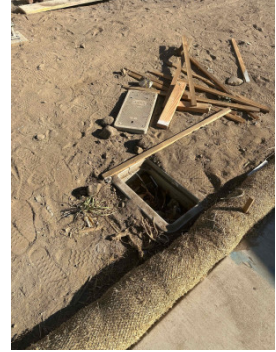
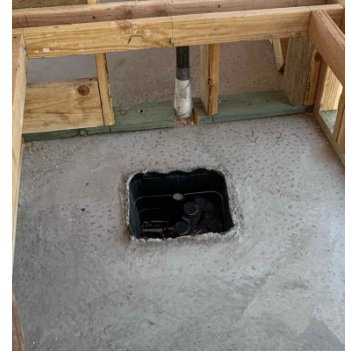
**Floor / Wall Openings**

Multiple Missing ground utility covers were observed. This presents a fault hazard.

All ground openings 12" x 12" or greater need to be properly covered to avoid fall injuries.

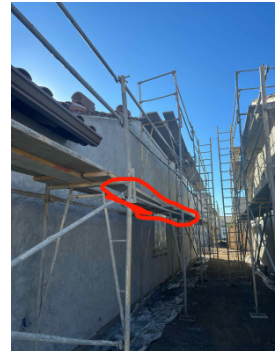
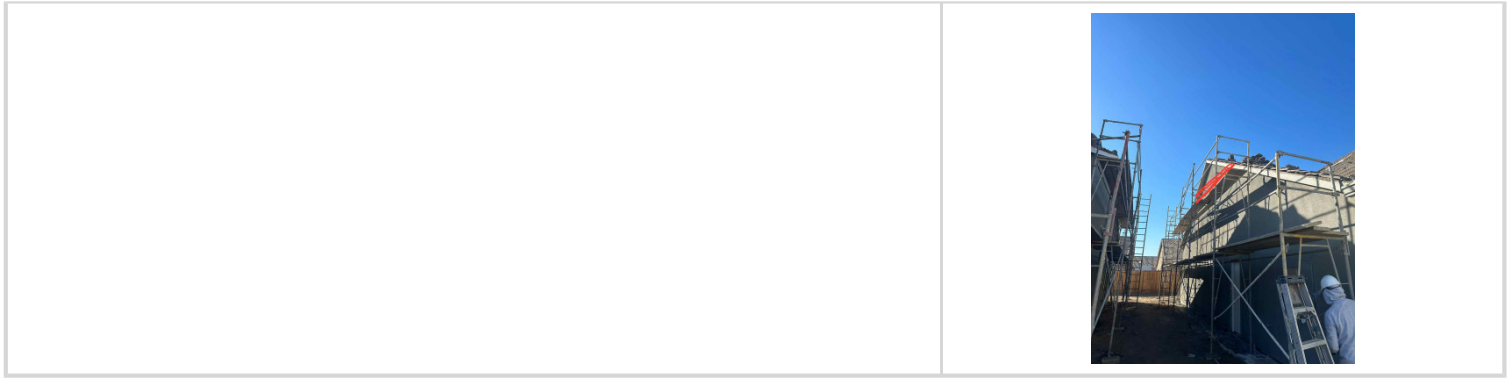
**Supported Scaffolding**

Scaffolding safety issues were observed, including the following:

- Missing toe boards
- Missing Planking
- Missing top and mid rail

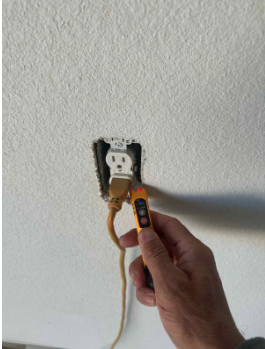
<b>Electrical Safety</b>	<b>Unsatisfactory</b>
--------------------------	-----------------------

Comment	
Outlet covers were missing off of temporary live electrical outlets. This presents an electrical shock hazard if exposed wires are contacted.
