SAFETY INSPECTION REPORT

CONDUCTED FOR:
FCB Homes

PROJECT:
Rose Gate II

INSPECTION TYPE:
General Construction

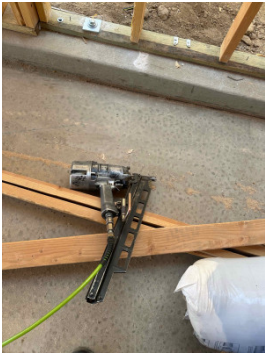
Pneumatic Nailers		Unsatisfactory
Comment

<p>Most Pneumatic nail guns were found in satisfactory condition with safety mechanisms in place.</p> <p>One pneumatic nail gun was found with missing Spring safety mechanism. (Tool was removed from service until it could be repaired.)</p>

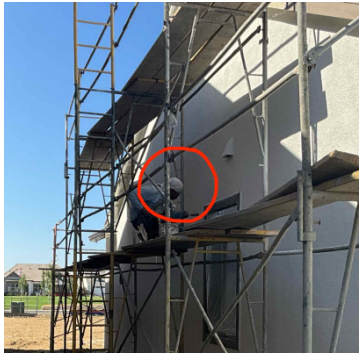
Personal Protective Equipment	Unsatisfactory
--------------------------------------	-----------------------

Most workers observed were wearing proper PPE for the task at hand.	-
---	---

<p>Painters were reminded to wear hardhats when working on scaffolding. (Corrected on the spot.)</p>

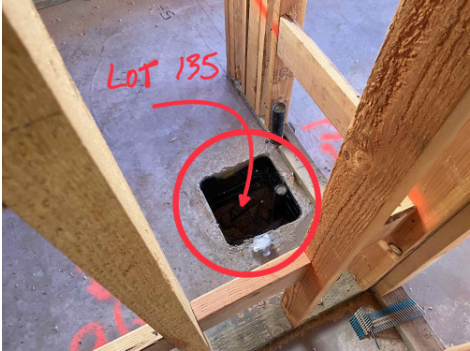
<p>Floor / Wall Openings</p>	<p>Unsatisfactory</p>
-------------------------------------	------------------------------

<p>Comment</p>	
<p>All ground openings 12" x 12" or greater need to be properly covered to avoid fall or trip hazards. - 135</p>

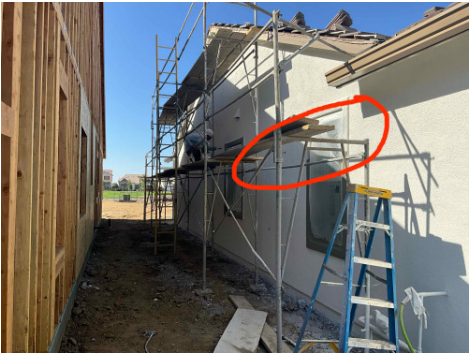
<p>Supported Scaffolding</p>	<p>Unsatisfactory</p>
-------------------------------------	------------------------------

<p>Scaffolding safety issues were observed, including the following: - missing plank</p>

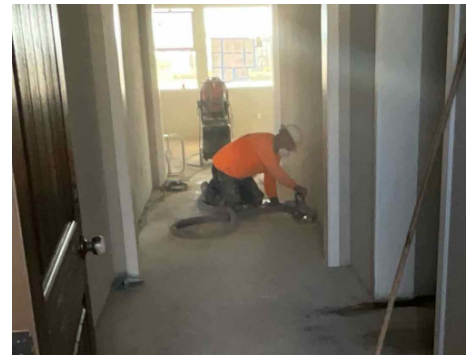
Silica Control	Satisfactory
Comment

Concrete floor sanding was being done with HEPA, vacuum, and respiratory protection in place.

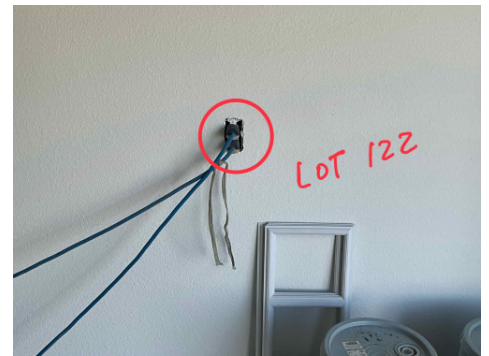
Electrical Safety

Outlet covers were missing off of temporary live electrical outlets. This presents an electrical shock hazard if exposed wires are contacted. - 122
