# SAFETY INSPECTION REPORT

**CONDUCTED FOR:**  
FCB Homes

**PROJECT:**  
Rose Gate II

**INSPECTION TYPE:**  
General Construction

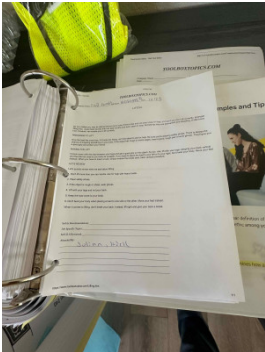
<b>Comment</b>	
Tailgates are being conducted at least every 10 working days

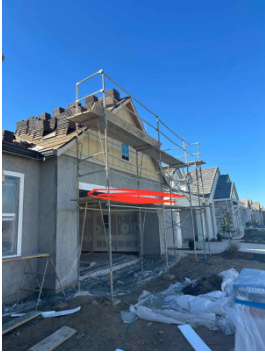
<b>Personal Protective Equipment</b>		<b>Unsatisfactory</b>
<b>Comment</b>		
Multiple workers were reminded of the importance of wearing hardhats on the construction site. (Correct on the spot.)		-
<b>Trenching &amp; Excavation</b>		<b>N/A</b>
<b>Comment</b>		
No trenching or excavating was observed at the time of inspection		-
<b>Fall Protection</b>		<b>N/A</b>
<b>Comment</b>		
No work requiring fall protection was observed on site.		-
<b>Guardrails</b>		<b>Satisfactory</b>
<b>Comment</b>		
Temporary guard rails were located in side of stairwell.		-
<b>Floor / Wall Openings</b>		<b>Satisfactory</b>
<b>Comment</b>		
No unprotected floor or wall openings were observed at the time of inspection.		-
<b>Supported Scaffolding</b>		<b>Unsatisfactory</b>
<b>Comment</b>		
Scaffolding safety issues were observed, including the following: - Missing planking. - Missing toe boards

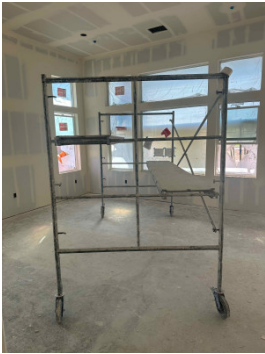
<b>Mobile Scaffolding</b>		<b>Satisfactory</b>

<p>Mobile scaffolding was found in satisfactory condition. Not in use at the time.</p>

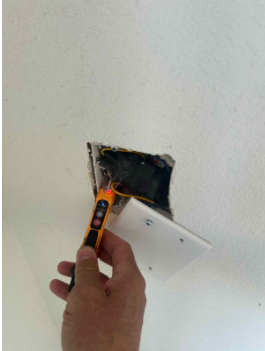
<b>Electrical Safety</b>	<b>Unsatisfactory</b>
--------------------------	-----------------------

<b>Comment</b>	
Outlet covers were missing off of temporary live electrical outlets. This presents an electrical shock hazard if exposed wires are contacted.

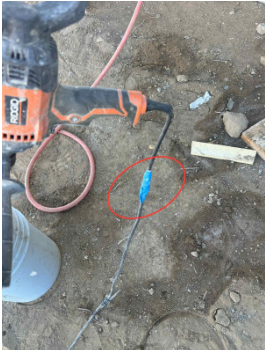
Plasterers had mixing drill with damaged electrical cord.
