SAFETY INSPECTION REPORT

CONDUCTED FOR:
Gonzalez Incorporated

PROJECT:
Chelsey at The Trails (Manteca)

INSPECTOR : BRITTON FIELD
DATE : MAY 21, 2024
CITY : MANTECA
STATE : CA

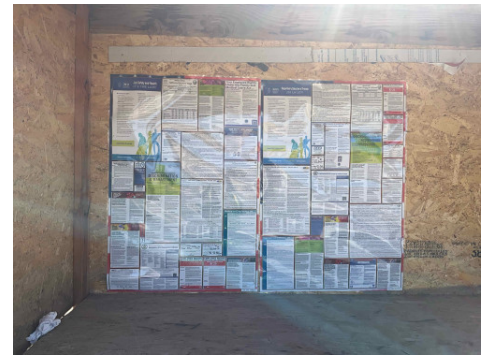
Labor Law Postings	Satisfactory
---------------------------	---------------------

2024 labor law posters are posted on Information board.

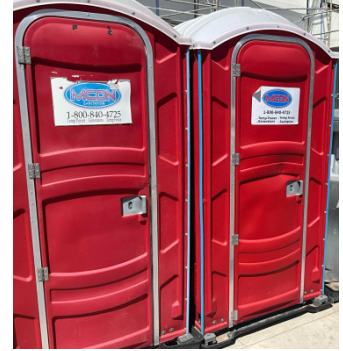
Restrooms near active work area were found in satisfactory condition.

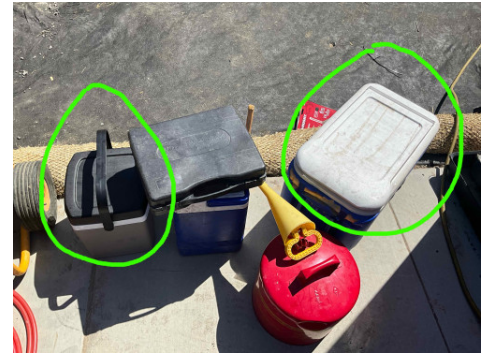
Potable Water

Bottle drinking water is available near the active work area.

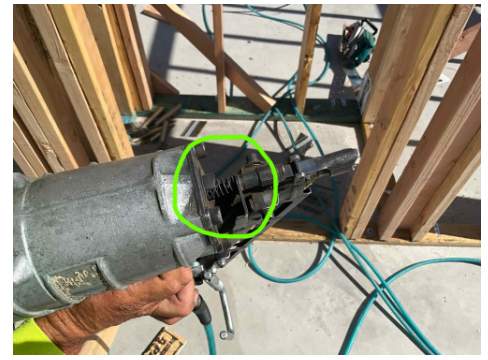
Pneumatic Nailers	Satisfactory
Comment

Pneumatic nail guns were being used safely and found in satisfactory condition. Safety mechanisms were in place.

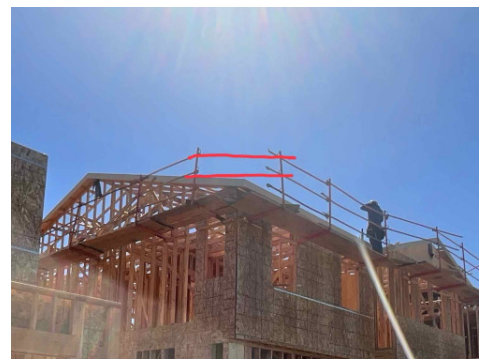
Suspended Scaffolding	Unsatisfactory
------------------------------	-----------------------

Roof scaffold was missing top rail and mid rails on corners.

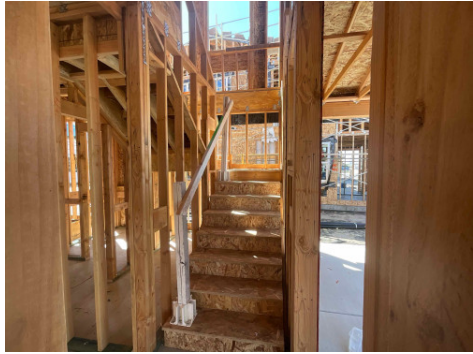
Stairways, Ramps, Runways	Satisfactory
----------------------------------	---------------------

Comment	
Temporary handrails were being installed inside of stairways.

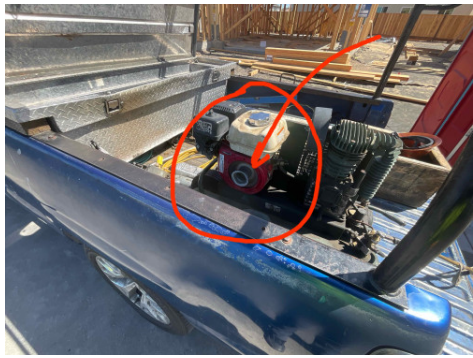
Other Items (that were observed)	Unsatisfactory
---	-----------------------

Gas powered air compressor had missing pulley wheel guard. This can result in entanglement injuries.
