SAFETY INSPECTION REPORT

CONDUCTED FOR:
Gonzalez Incorporated

PROJECT:
Parkwood Crossroads West

INSPECTION TYPE:
General Construction

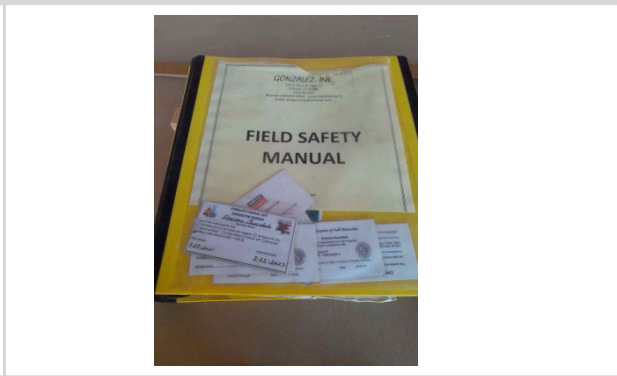
Safety Program (Including IIPP) **Unsatisfactory**

The IIPP / safety manual is located inside of foreman's truck, but was not located on site.

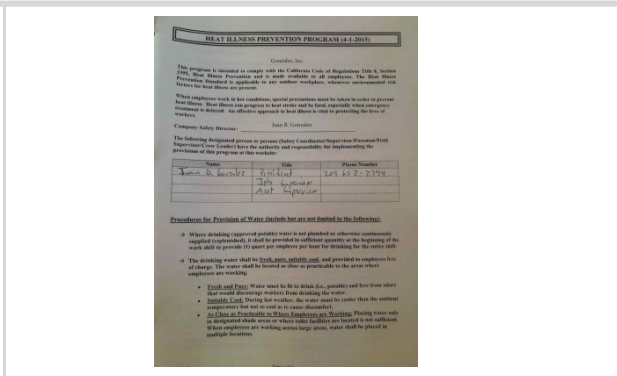
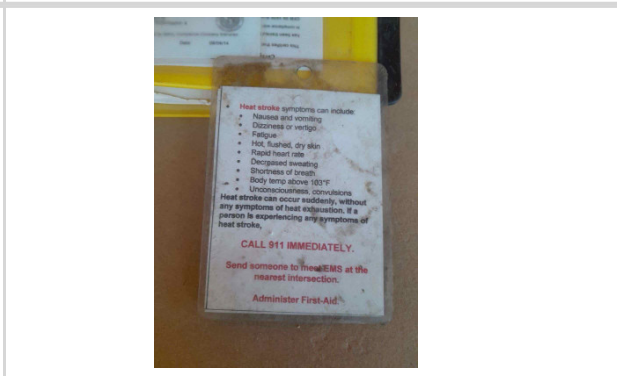
Heat Illness Prevention Program **Unsatisfactory**

Heat illness program is available, but was not located on site at the time of inspection. (Eric corrected this.)

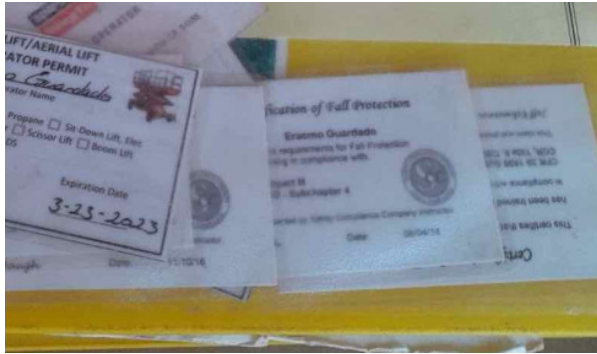
First Aid / CPR Certification Satisfactory

Comment	
Foreman has his current CPR/first aid certification.

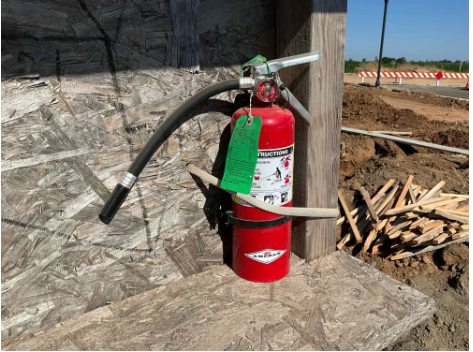
Fire Extinguisher(s)	Satisfactory
-----------------------------	---------------------

Comment	
<p>Fire extinguisher was found in satisfactory condition. Extinguisher is being inspected and documented monthly. (Note: fire extinguisher should be kept near the active work area where gas powered generators and compressors are being used.)</p>

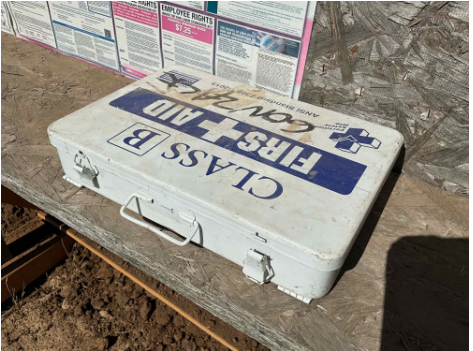
First Aid Kit(s)	Satisfactory
-------------------------	---------------------

Comment	
<p>First aid kit was found in satisfactory condition and well stocked.</p>

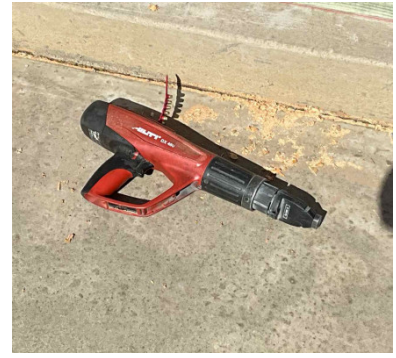
Powder Actuated Tools	Unsatisfactory
------------------------------	-----------------------

Powder actuated nail gun and live rounds were found unattended. These items should be in possession of the licensed user or stored in a secure location. (Corrected on the spot.)

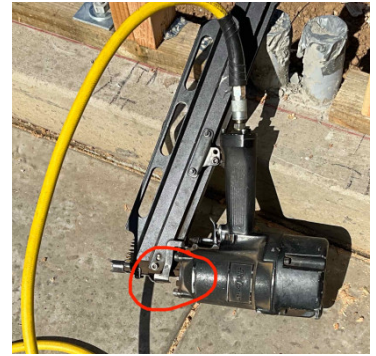
Pneumatic Nailers **Unsatisfactory**

Pneumatic nail gun was found with missing safety mechanism Spring. The nail gun was removed from service till it can be repaired.

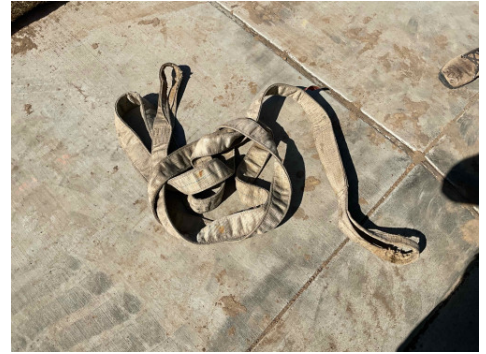
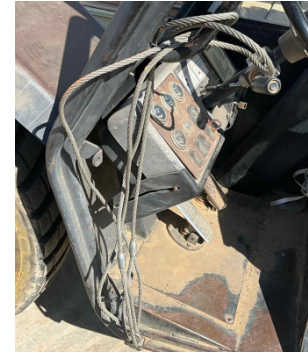
Rigging Operations

All reach lift rigging was inspected and found in satisfactory condition.
