PROJECT INSPECTION

Company	Graham Prewett	Type of Inspection:	Roofing
Project	1765-Crookham ES Gym	Date of Inspection	December 03, 2024
Inspector Name	Gabino Vidrio	Time of Inspection	09:04 AM

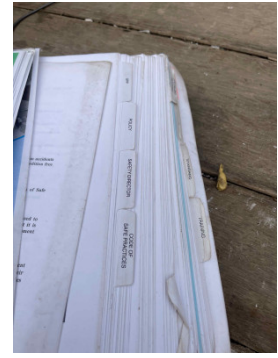
Is the company safety manual on site? **Satisfactory**

Company safety manual is on site is located at the foreman truck

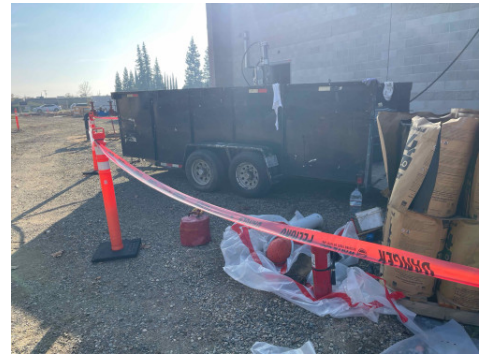
If performing hot work, have all safety precautions been taken?

Hot work is being done properly and safely taken precautions to install .
Being trained how to work using using hot asphalt and cold process

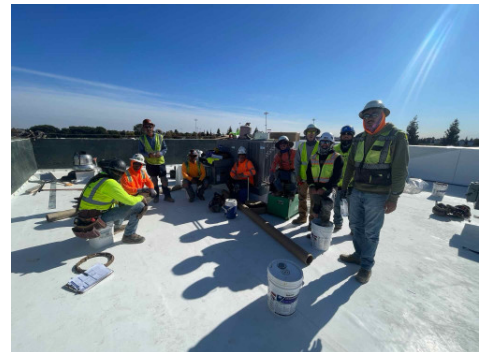
Is Personal Protective Equipment being worn as required?

Personal protective equipment is being used and available to the workers

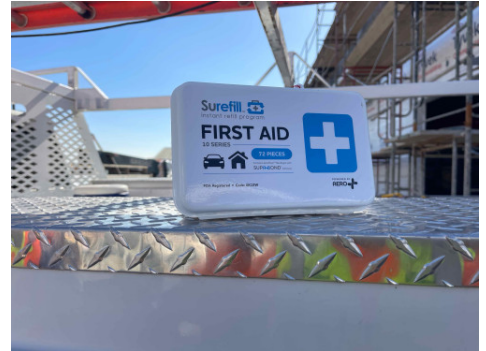
Is emergency equipment including first aid kit and fire extinguisher(s) available?

Emergency and first aid kit was found on the roof and the foreman truck

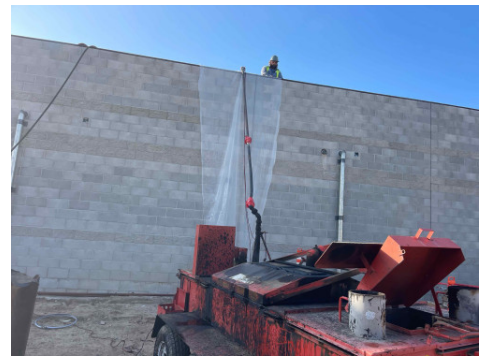
Are tools & equipment are being used safely?

All tools and equipment are being used safely and being inspected daily

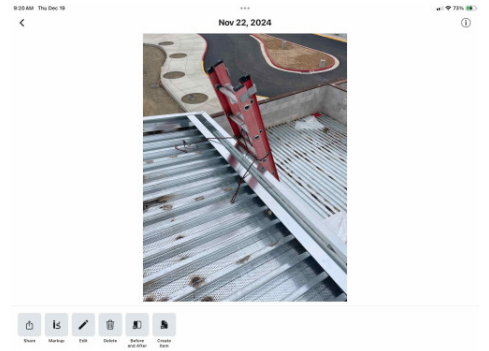
Are extension ladders in safe condition, set up at a 4:1 pitch, secured, and extend at least 3' above the roof platform?

Extension ladders are extend 3 feet above the landing platform and being tied off

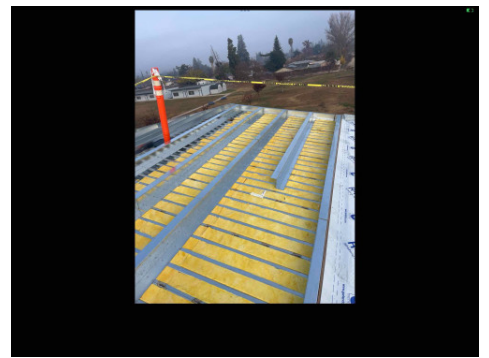
If personal fall restraint / arrest systems are being used, are the anchors and lanyards set up correctly?

Personal fall arrest is being used and by sheet metal crew and anchor points are being set at the perimeter of the roof

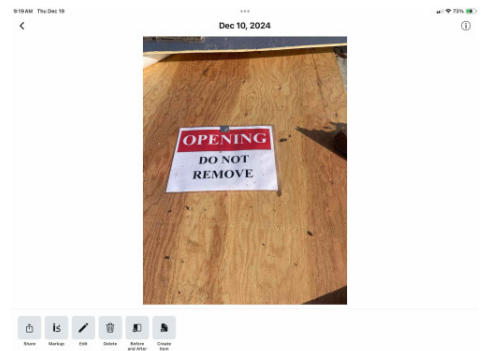
Are all interior openings larger than 12"x12" fully and adequately covered, secured, and clearly marked "OPENING - DO NOT REMOVE"?

All interior openings are covered and mark conduit pipes are covered

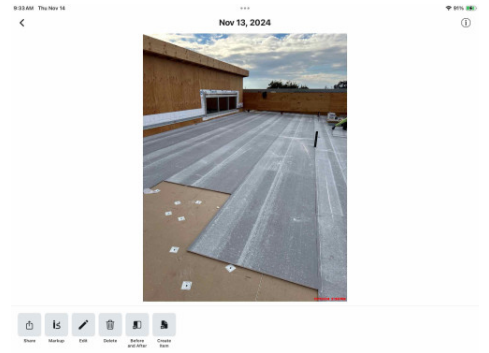
Is the roof surface safe and stable, and able to adequately support walking on it?

Roof surface is strong to walk on the roof and be able to support weight and to walk on it

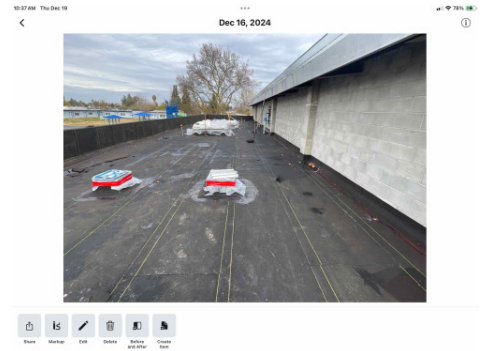
Are all other items in a safe condition?

All other items are in good condition and working properly
