SAFETY INSPECTION REPORT

24-009 Fine Arts Cypress College

General Construction

DATE : OCTOBER 23, 2024

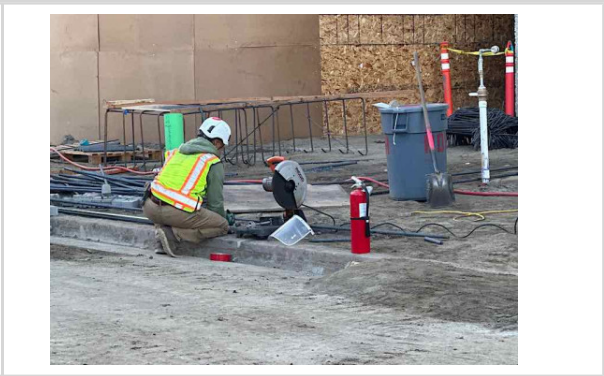
Power Tools	Unsatisfactory
--------------------	-----------------------

Inland worker is using a chop saw that is missing the guard. The worker noted he did not realize the guard was missing. Please train workers of the requirement to inspect power tools prior to use. Please train workers the requirement to use proper Lock Out Tag Out of deficient tools so other workers are not affected by a deficient tool. The worker removed the tool immediately.

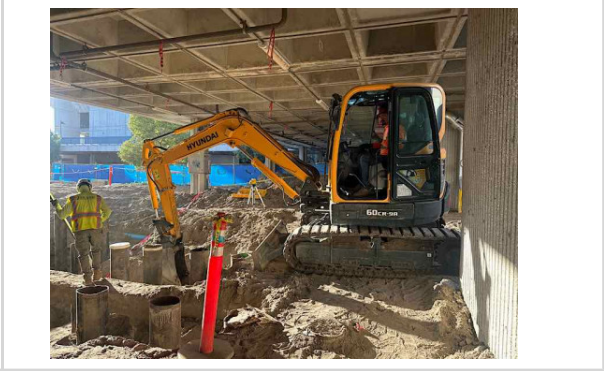
Heavy Mobile Equipment (Excavators, Loaders, etc)	Unsatisfactory
----------------------------------------------------------	-----------------------

The mini ex is in operation, however a daily inspection was not completed prior to use. Please train workers the importance of a daily inspection documented prior to the equipment in use. The foreman noted and was completing the inspection record.

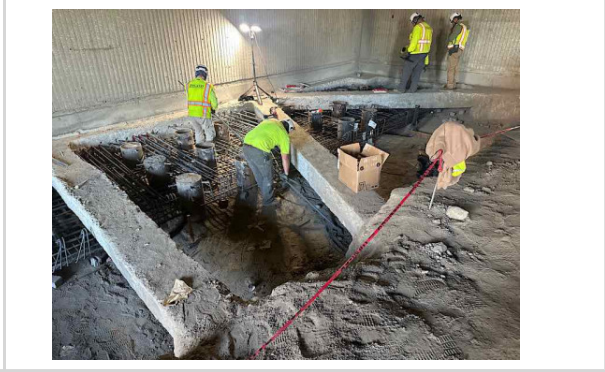
Personal Protective Equipment	Satisfactory
--------------------------------------	---------------------

PPE was in good order throughout the site.

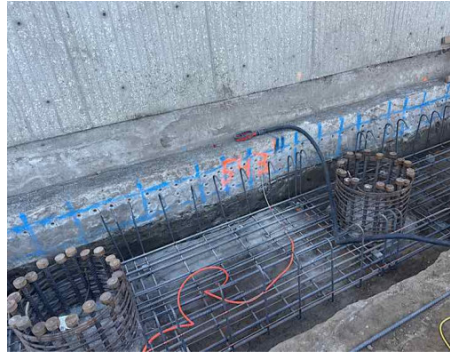
Silica Control	Satisfactory
-----------------------	---------------------

Workers are observed to be using vacuum shrouds to control silica dust during blowing operations.

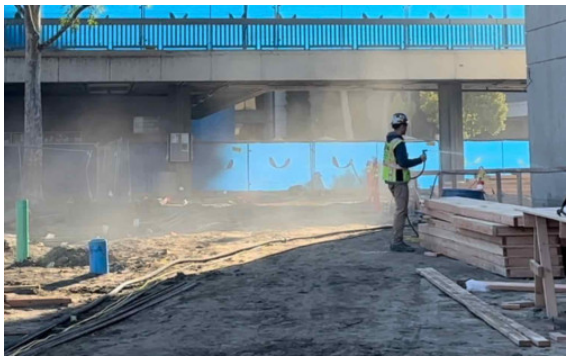
Sand blasting activities are in progress. The sand blasting contractor has sufficient PPE as we as dust control. Water is being added to the top of the footing. Water is also used with the compressed air for the sand blasting. It is noted a water vapor is developing from the blasting activity. The blasting company has documentation noting the steel bits being shot do not contain silica. However, there is an uncertainty of the water vapor containing traces of silica from the small amounts of loose dust inside the holes. Therefore, the foreman closed off access through the blasting area to only those working in the area. In addition, workers around the area complied to don respiratory protection as a safeguard in the event of traces of silica dust are in the water mist. If needed, a further action was discussed to create a barrier similar to a containment barrier. A moveable section of pvc pipe with 3mm plastic that would loosely envelope to blasting area. The moveable containment could follow the process, trap water mist and thereby trap silica dust within. This would also eliminate any mist cloud from spreading throughout the site. All was discussed with the foreman.
