SAFETY INSPECTION REPORT

CONDUCTED FOR:
Majestic Masonry

PROJECT:
1232 High St

INSPECTOR : JOSHUA JOHNSON
DATE : AUGUST 22, 2024
CITY : OAKLAND
STATE : CA

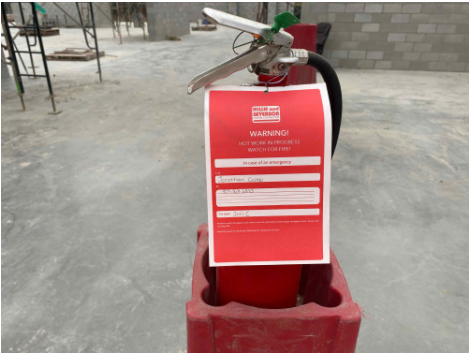
Fire Extinguisher(s)	Satisfactory
Comment

<p>Available throughout the site.</p>

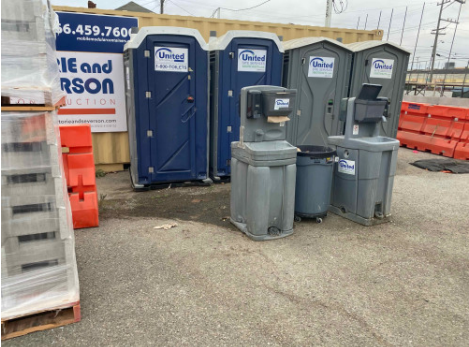
<p>Restrooms Satisfactory</p>	
<p style="text-align: center;">Comment</p>	
<p>Stocked and clean.</p>

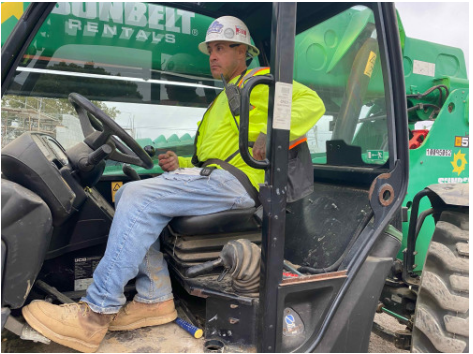
Powered Industrial Trucks	Satisfactory
Comment	
Safe operation observed. Good job wearing your seatbelt!

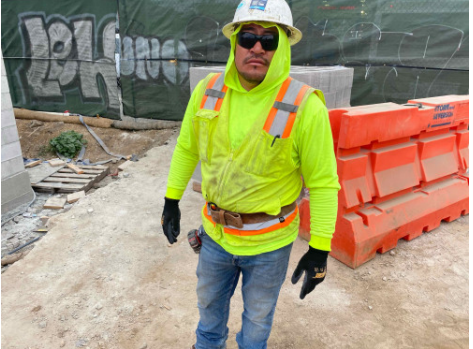
Comment	
Good PPE usage observed during the visit.

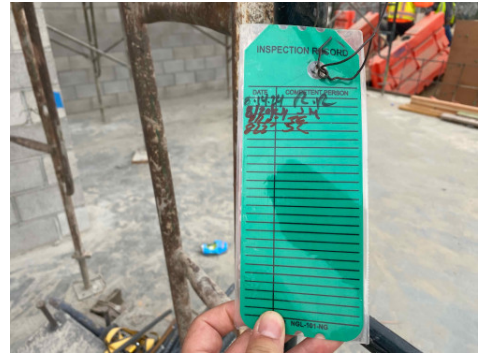
Good job using the green tag system.

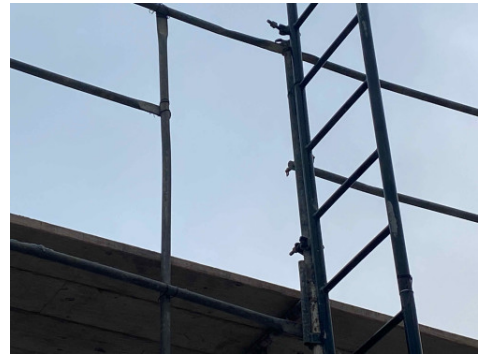
Fall hazard at ladder access location. Consider using a gate for access. See additional photo for more information.

- Fall hazards observed at ladder access points. Ensure gates are installed to mitigate this hazard.
- Fall hazards observed of sidebrackets. Esure railings are installed.
- Toe boards missing at locations of access and egress. Ensure they are added.

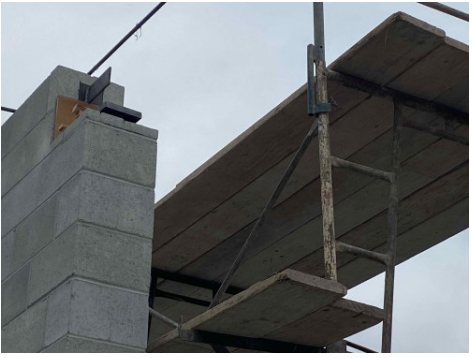
<p>Fall hazard due to know rails being on the side bracket platform. See example of P rail that can be used.</p>

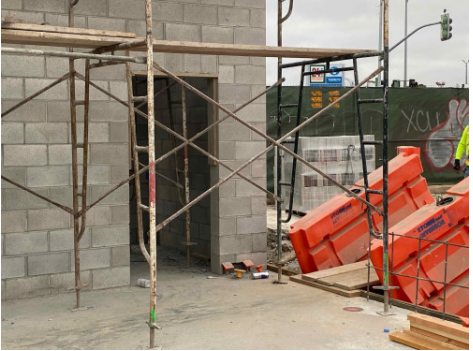
<p>Toe boards needed above this ramp and walkway. Toe boards protect from falling debris.</p>

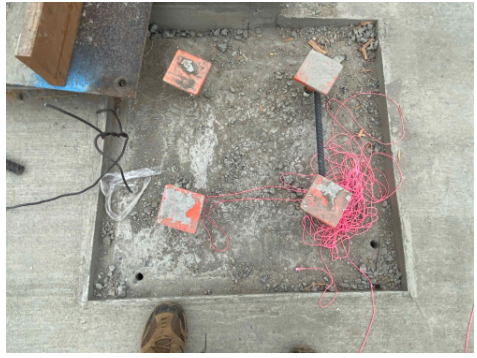
Good job protecting hazards.

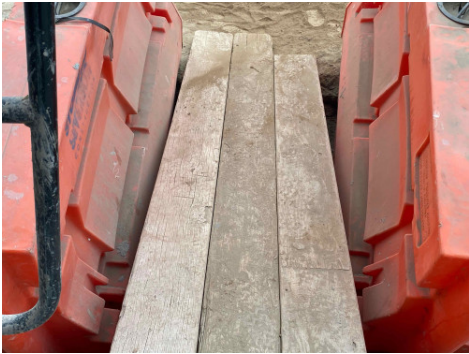
Safe ramps observed.
