# SAFETY INSPECTION REPORT

**CONDUCTED FOR:**  
Pacific Hydrotech Corporation

**PROJECT:**  
Las Lomas Booster

**INSPECTION TYPE:**  
General Construction

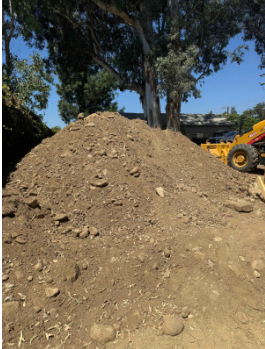
<b>Trenching &amp; Excavation</b>	<b>Satisfactory</b>
-----------------------------------	---------------------

<b>Comment</b>	
Excavations are under 4 ft deep.

Good job keeping spoils back over 2 feet away from trenches.

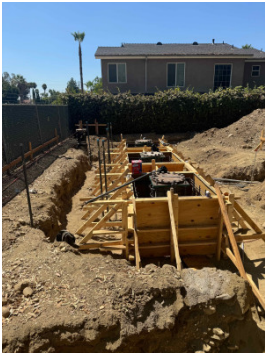
<p>Another view of the trench. Forms and rebar have been set. Pressure testing is being done today.</p>
