# SAFETY INSPECTION REPORT

**CONDUCTED FOR:**  
Pacific Hydrotech Corporation

**PROJECT:**  
Saddleback Reservoir

**INSPECTION TYPE:**  
General Construction

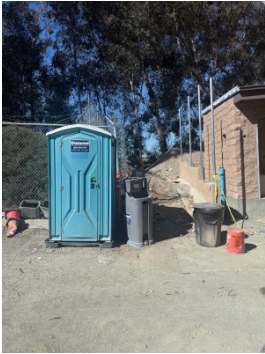
<b>Restrooms</b>	<b>Satisfactory</b>
<b>Comment</b>	
A restroom, wash station and trash bin are on site.

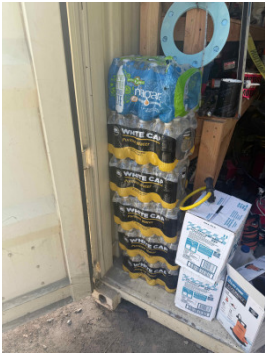
<p>Ample water is on site.</p>

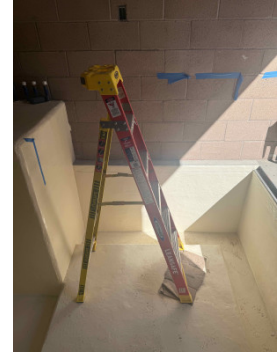
Ladders seen on site are in good condition and also have legible labels.

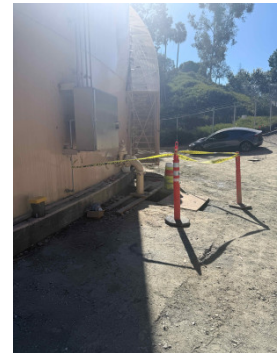
Good job delineating trenches on site.
