SAFETY INSPECTION REPORT

CONDUCTED FOR:
Pacific Hydrotech Corporation

PROJECT:
SJVGWTF

INSPECTION TYPE:
General Construction

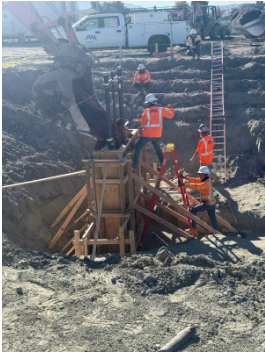
Ladders		Unsatisfactory
Comment		
Employee was seen using an A frame ladder improperly. He was asked multiple times to use an extension ladder as he can not have his back to the ladder and must maintain 3 points of contact at all times.

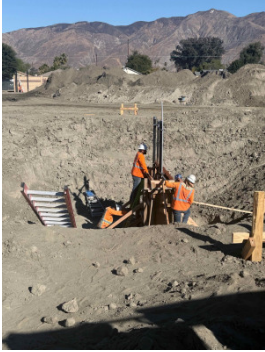
Extension ladder was later used.

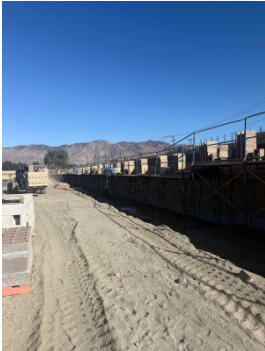
Comment	
Scaffolding was seen to be erected properly.

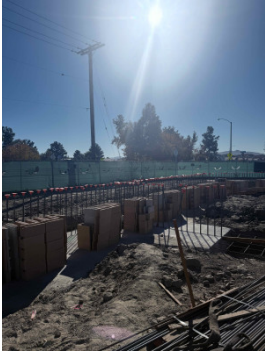
Comment	
Impalement hazards are capped throughout the site. Great job.
