SAFETY INSPECTION REPORT

CONDUCTED FOR:
Seaside Steel Inc.

PROJECT:
49000 Milmont

INSPECTION TYPE:
General Construction

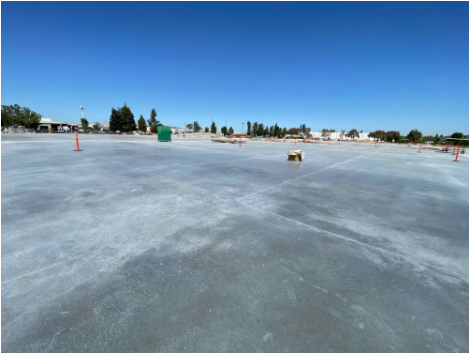
Access / Egress		Satisfactory
Comment		
Good access and egress are in place.

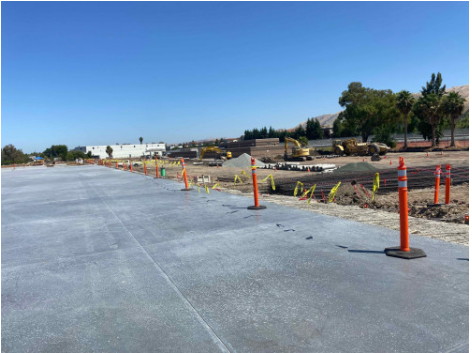
No concerns observed. Good job having delineation lines in place.

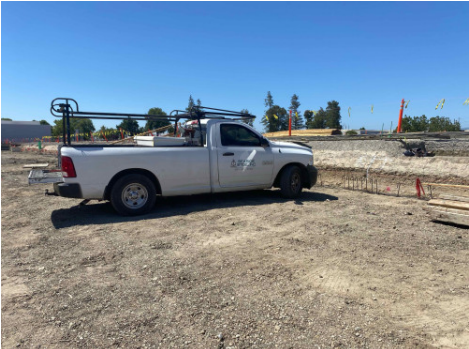
Other Items (that were observed)	Satisfactory
Comment	
Safe parking and vehicles observed.
