# SAFETY INSPECTION REPORT

**CONDUCTED FOR:**  
Seaside Steel Inc.

**PROJECT:**  
Little Dipper (Sacramento)

**INSPECTION TYPE:**  
General Construction

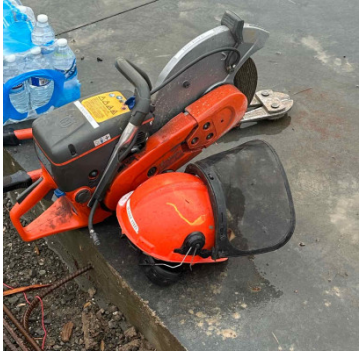
<p>Power saw was found in satisfactory condition.</p>

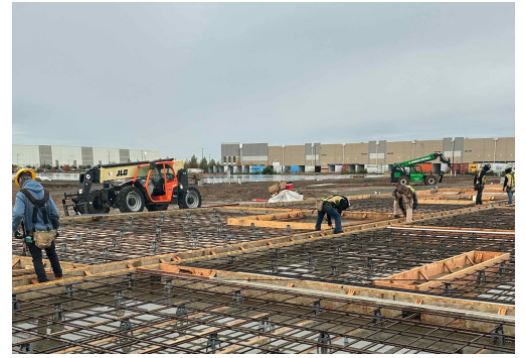
All workers were wearing appropriate PPE for the task at hand.
