# SAFETY INSPECTION REPORT

**CONDUCTED FOR:**  
Seaside Steel Inc.

**PROJECT:**  
Little Dipper (Sacramento)

**INSPECTION TYPE:**  
General Construction

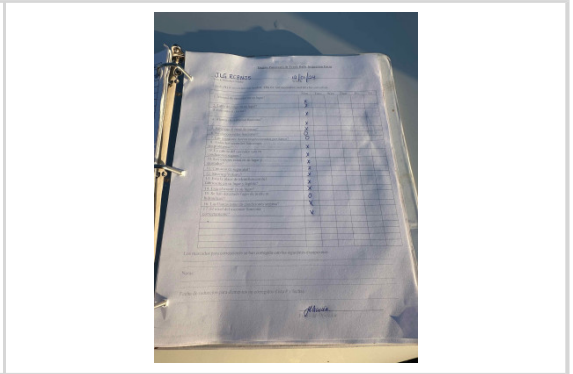
Equipment inspections are being performed daily. • Reach Lift
--

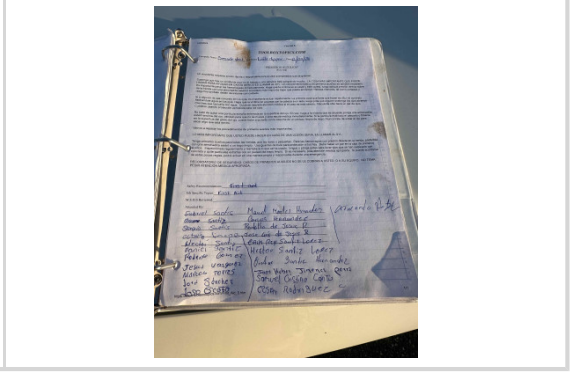
Tailgate meetings are being conducted each week. Sign in sheets are handed into the GC (buzz oats)
--

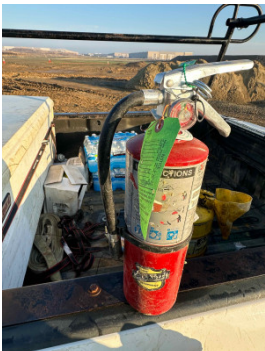
<b>Fire Extinguisher(s)</b>	<b>Unsatisfactory</b>
<b>Comment</b>	
Most fire extinguishers were found in satisfactory condition at the time of inspection.	-
One fire extinguisher was found in satisfactory condition. However, the extinguisher has not been inspected or documented monthly. (Carlos is correcting this.)

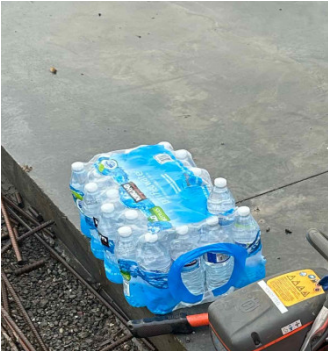
<b>Comment</b>	
Drinking water was provided.

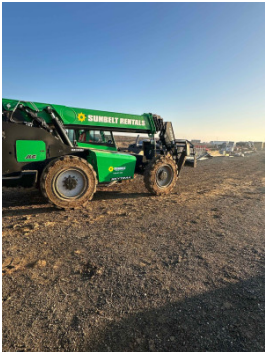
Reach Lift operator was wearing seatbelt at the time of inspection.

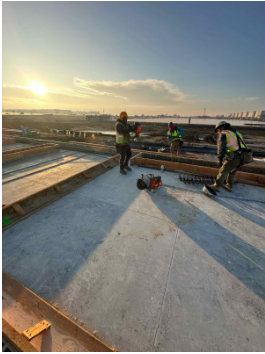
Most workers were wearing appropriate PPE for the task at hand.	-
---	---

Worker using power saw for cutting rebar was reminded to wear hearing protection when operating cutter. (Raul corrected on the spot.)
