# SAFETY INSPECTION REPORT

**CONDUCTED FOR:**  
Seaside Steel Inc.

**PROJECT:**  
Patterson BTS

**INSPECTOR :** BRITTON FIELD  
**DATE :** MAY 07, 2024  
**CITY :** PATTERSON  
**STATE :** CA

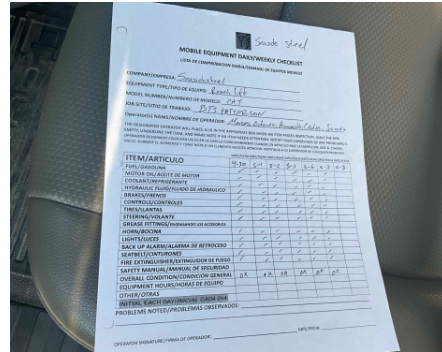
Daily inspections are being performed and documented daily using the SCC app.

Equipment inspections are being done daily.

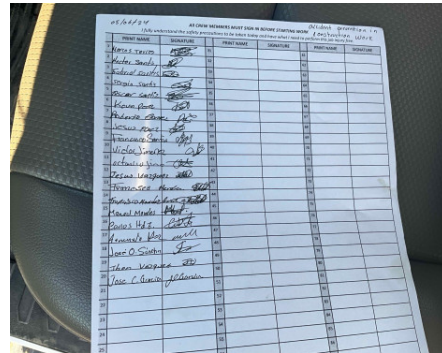
Safety meetings are being held regularly and documented. (This week: accident prevention and construction work)

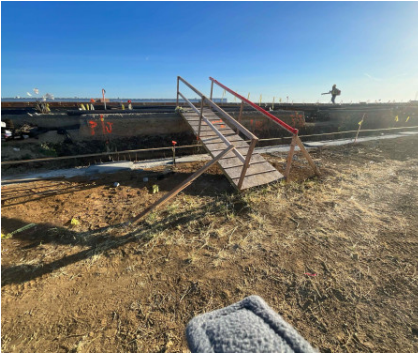
<b>Comment</b>	
Temporary ramps with guard rails have been set up for access to the active work area.

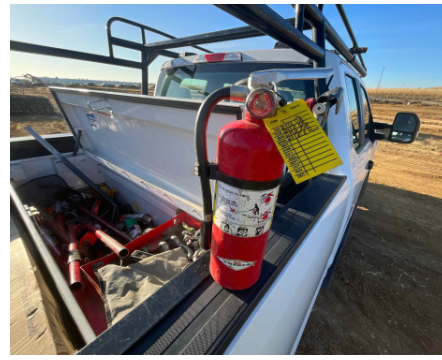
Fire extinguishers were found in satisfactory condition. Monthly inspections and documentation are being done.

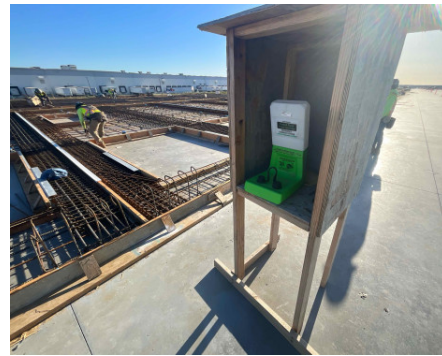
Eye wash bottles are located inside of foreman's truck. Also, stations are set up throughout the active work area from the GC.

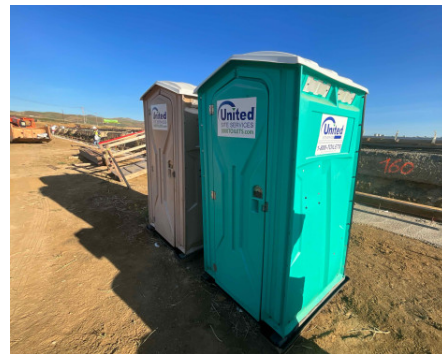
Restrooms were found in satisfactory condition near active work area.

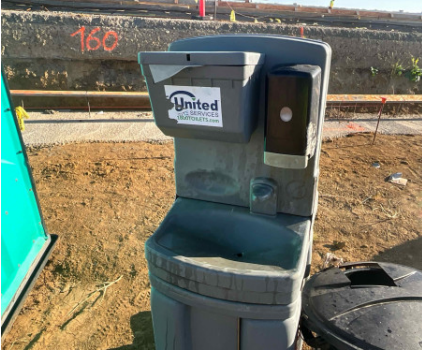
<b>Comment</b>	
Wash station was found in satisfactory condition. - Soap was available - Paper towels are stocked. - non-drinkable water sign was clearly visible

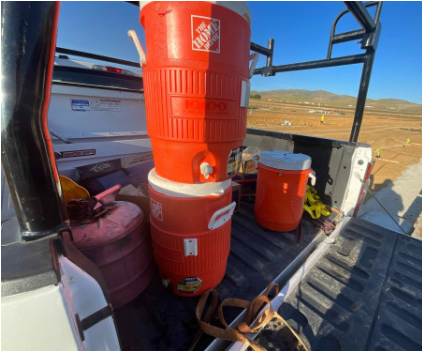
<b>Comment</b>	
Three 5 gallon thermoses of cool water are provided. Drinking cups, and trash bag is also located near the drinking station.

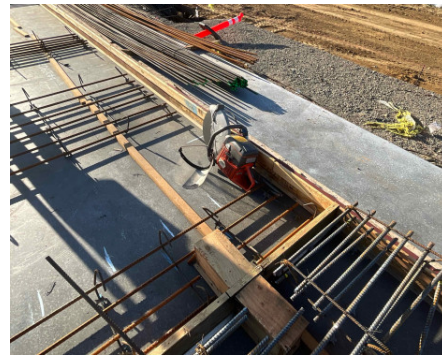
Power saw used for cutting rebar was found in satisfactory condition.

- Face shield was provided to guard against injuries.
- fire extinguisher was located nearby in the event of fire.

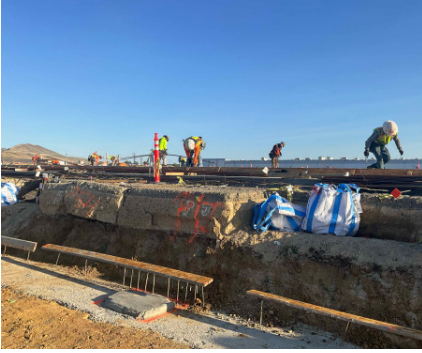
<b>Personal Protective Equipment</b>		<b>Satisfactory</b>
<b>Comment</b>		
All workers were observed, wearing proper PPE for the task hand. This includes gloves and eye protection.

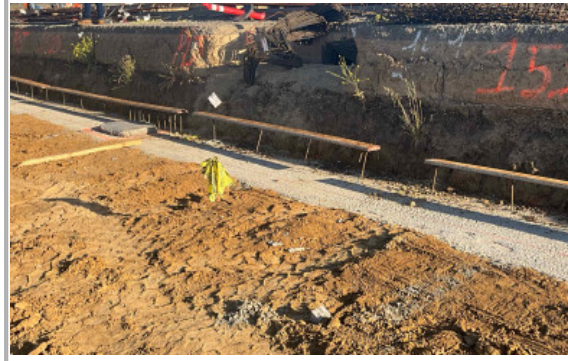
All SSI impalement hazards have been properly capped to avoid injuries.

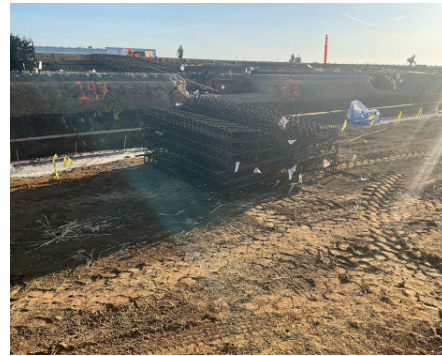
Active work area was kept free of debris. Materials were stacked in a neat and organized manner.

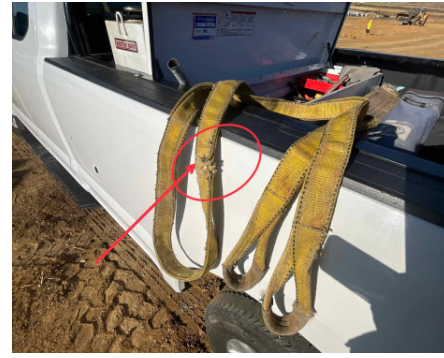
Reach lift rigging strap was found torn and compromised on the reach lift. This strap is apparently not SSI's. However SSI will remove it from service. (Strap was located behind seat of reach lift. Strap was displayed on side of truck for picture.)
