# SAFETY INSPECTION REPORT

**CONDUCTED FOR:**  
Seaside Steel Inc.

**PROJECT:**  
Patterson BTS

**INSPECTION TYPE:**  
General Construction

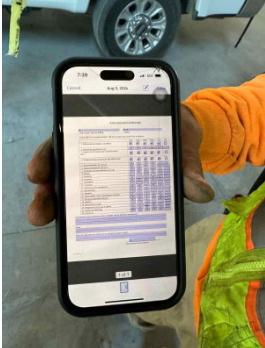
<b>Daily Inspections</b>	<b>Satisfactory</b>
<b>Comment</b>	
Daily inspections are being performed and documented daily using the SCC app.

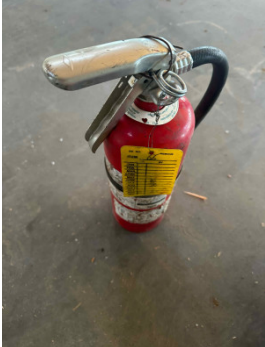
Charged fire extinguishers are located near the active work area.	-
---	---

Extinguishers are being inspected and documented monthly.

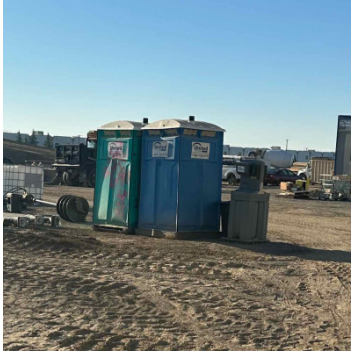
<b>Comment</b>	
Restrooms were found in satisfactory condition near active work area.

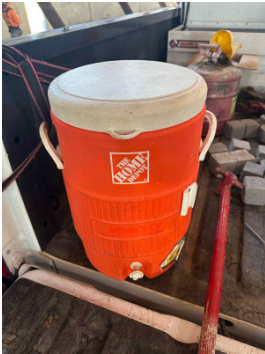
<b>Comment</b>	
A 5 gallon thermoses of cool water are provided. Drinking cups, and trash bag is also located near the drinking station.

Suggestion was given to safety, seal the water container, date, and time last replenished.	-

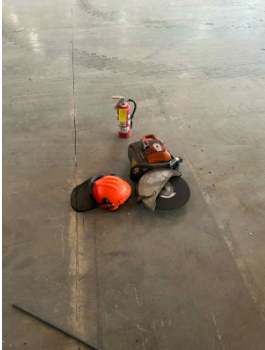
<b>Power Tools</b>	<b>Satisfactory</b>
<b>Comment</b>	
Power saw used for cutting rebar was found in satisfactory condition. Face shield and ear protection are provided.

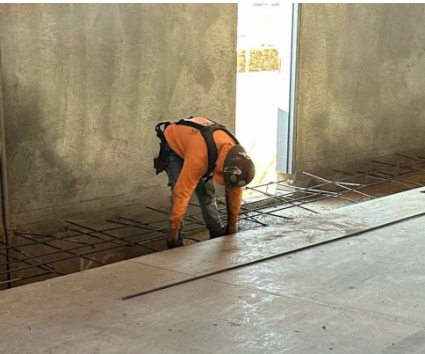
<b>Comment</b>	
One worker was reminded of the importance of wearing gloves when handling rebar or other sharp objects. (James corrected on the spot.)
