# SAFETY INSPECTION REPORT

**CONDUCTED FOR:**  
Seaside Steel Inc.

**PROJECT:**  
Project Sunrise (Rancho Cordova)

**INSPECTION TYPE:**  
General Construction

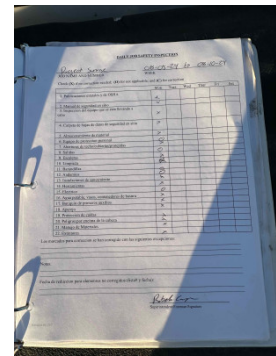
**Daily Inspections**

Daily inspections are being performed

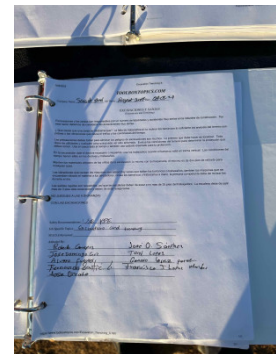
**Tailgate Meetings**

Tailgates are being conducted at least every 10 working days

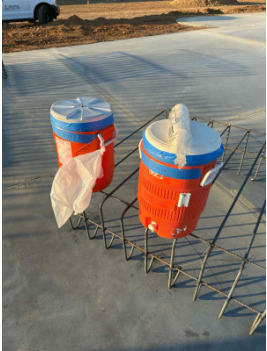
<b>Potable Water</b>	<b>Satisfactory</b>
----------------------	---------------------

5 gallon thermoses of cool water are provided. Drinking cups, and trash bag is also located near the drinking station.

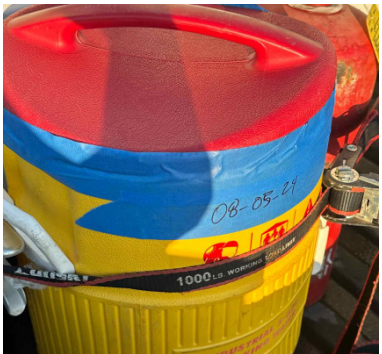
Water cooler safety seal was in place and properly dated with time of last replenishment.

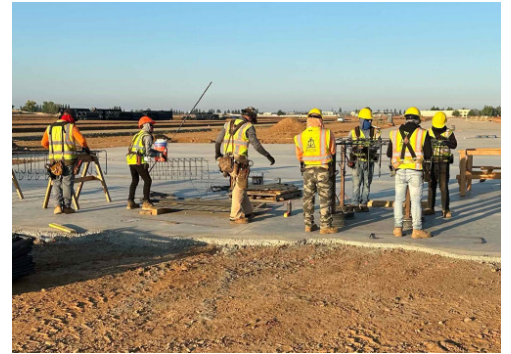
### Personal Protective Equipment

All workers observed were wearing proper PPE for the task at hand.
