# SAFETY INSPECTION REPORT

**CONDUCTED FOR:**  
Silverwood Landscape Construction, Inc.

**PROJECT:**  
Los Olivos

**INSPECTION TYPE:**  
General Construction

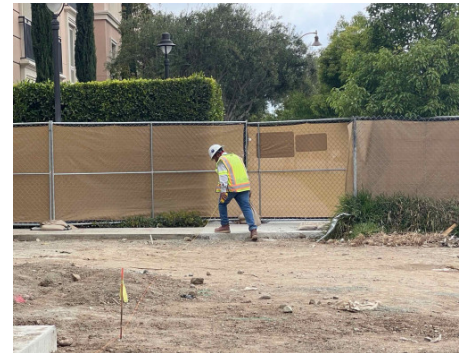
**Site Contact**

Satisfactory

Miguel Montalva was on site.

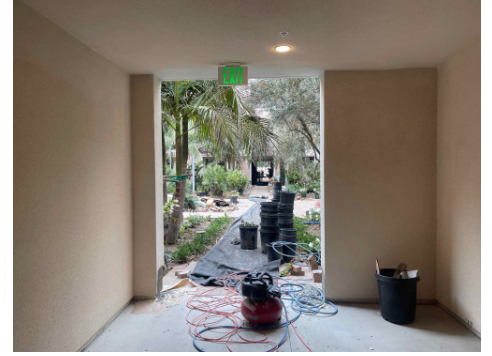
The only correction was on keeping the access to the courtyard free of material and equipment. The courtyard wasn't very large and multiple crew's were working in the area. I told the team to attempt to keep their empty buckets from blocking the entrance.

The majority of the crew were working in a courtyard where the entrances and exits were blocked by material. The crew were asked to attempt to keep these routes clear as it would be necessary to escape the area in the event of an emergency.

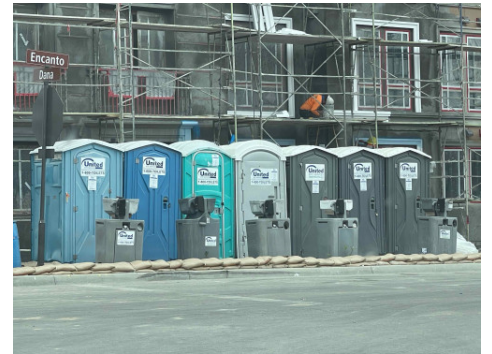
**Restrooms**

**Satisfactory**

Plenty of restrooms are available around the job-site.

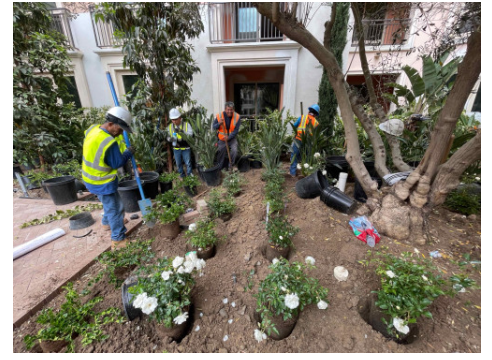
**Potable Water**

**Satisfactory**

Additional water was available in the company truck. The crew working in the courtyard brought a pack of water with them to have near their work location.

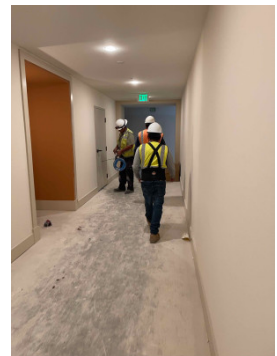
**Shade**

**Satisfactory**

Permanent structures on site provide plenty of shade. Crew's are permitted to enter the buildings if necessary.

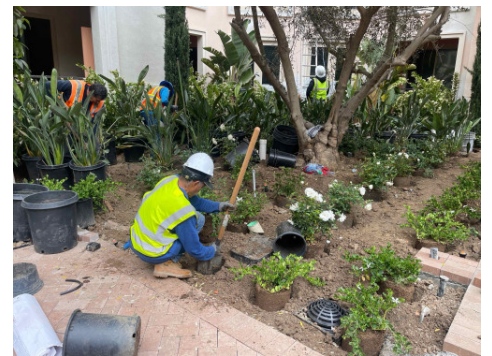
**Hand Tools**

**Satisfactory**

Hand tools on site were in fair condition.

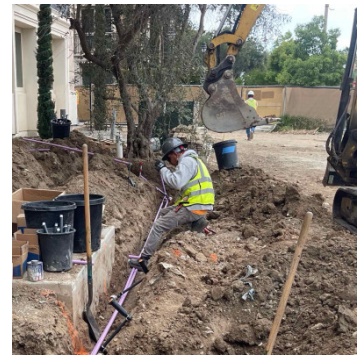
Hand tools on site were in fair condition.

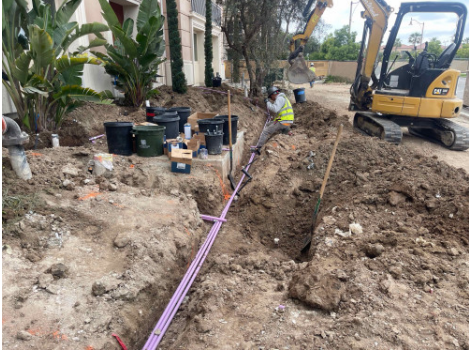
<b>Trenching &amp; Excavation</b>	<b>Satisfactory</b>
-----------------------------------	---------------------

<b>Comment</b>	
<p>Trenches observed on site were being completed in a compliant manner. No trench on site exceeded 2'.</p>
