# SAFETY INSPECTION REPORT

**CONDUCTED FOR:**  
Teserra Outdoors

**PROJECT:**  
Fish remodel

**INSPECTION TYPE:**  
General Construction

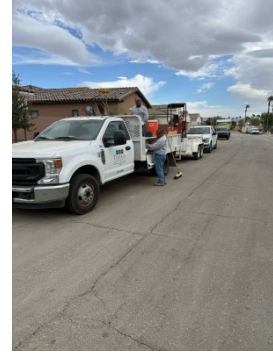
<b>Emergency Items</b>	
<b>Access / Egress</b>	<b>Satisfactory</b>
<b>Comment</b>	<b>Teressa Outdoors</b>

Availability of emergency medical service for workers on site

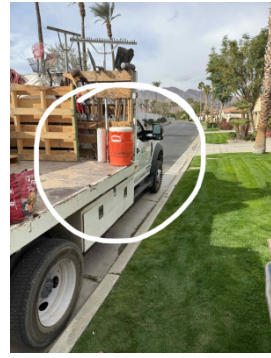
**Potable Water**

Provide clean

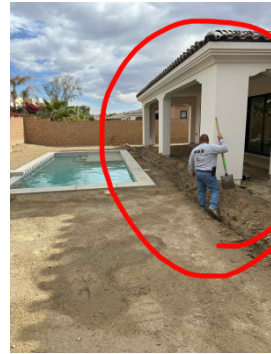
**Shade**

Shade on site and suitable

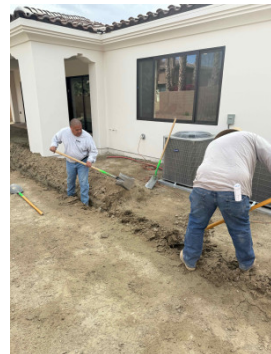
**Hand Tools**

Tools at that time of inspection were just shovels and rakes

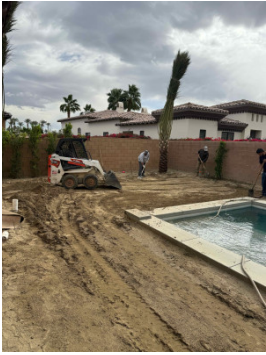
<b>Heavy Mobile Equipment (Excavators, Loaders, etc)</b>	<b>Satisfactory</b>
--	---------------------

<b>Comment</b>	<b>Teressa Outdoors</b>
Back alarm was working on bobcat need to make sure that operator has competent Person trained under Cal OSHA guidelines

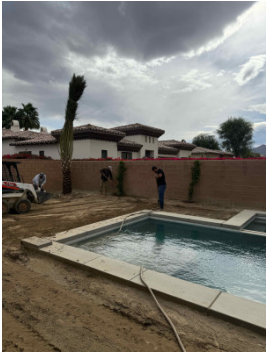
<b>Personal Protective Equipment</b>	<b>Unsatisfactory</b>
--------------------------------------	-----------------------

<b>Comment</b>	<b>Teressa Outdoors</b>
Workers on ground need to have class two safety vest and possibly dust mask available if wind is blowing

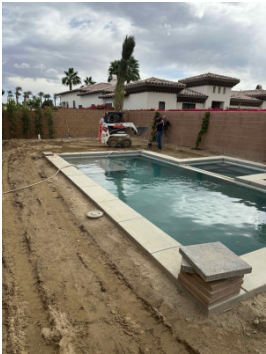
<b>Housekeeping</b>	<b>Satisfactory</b>
---------------------	---------------------

<b>Comment</b>	<b>Teressa Outdoors</b>
Housekeeping in good shape.

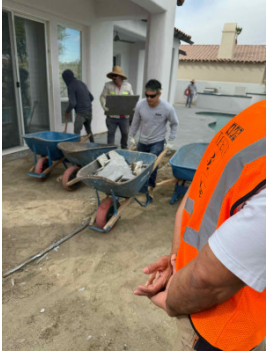
<b>Demolition</b>		<b>Satisfactory</b>
<b>Comment</b>	<b>Teserra Outdoors</b>	
Silica is controlled
