SAFETY INSPECTION REPORT

PROJECT:
The Park @ Granite Bay

INSPECTION TYPE:
General Construction

INSPECTOR : MARTIN RODRIGUEZ
DATE : AUGUST 28, 2024
CITY : GRANITE BAY
STATE : CALIFORNIA

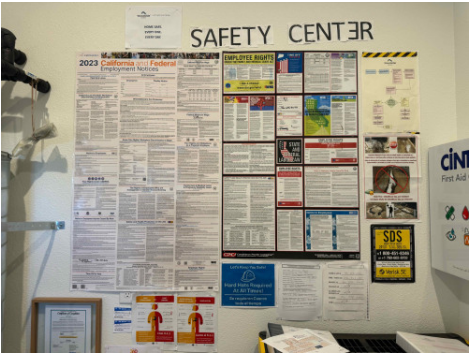
Labor Law Postings	Satisfactory
Comment	
Labor postings are posted in office.

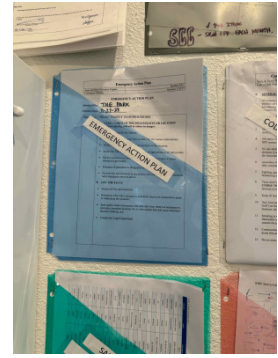
Emergency / Other Postings	Satisfactory
-----------------------------------	---------------------

Elegance information is available in the office.

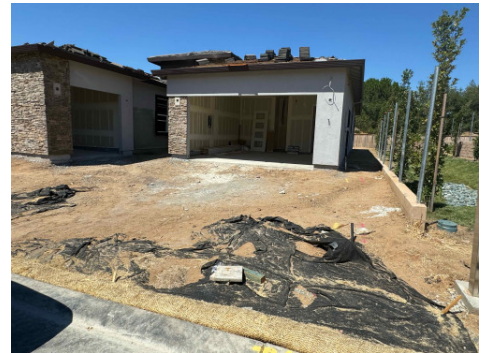
Access / Egress

Acces/egress is maintained.

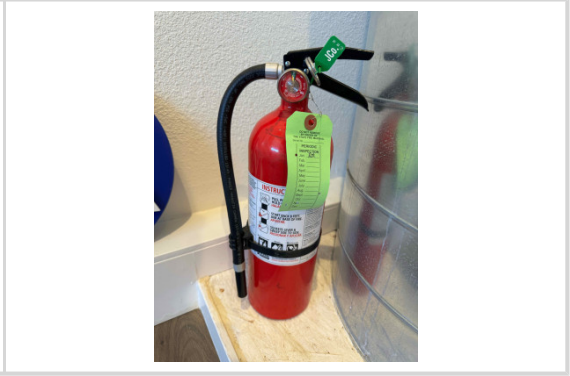
Fire Extinguisher(s)

Fire extinguisher is charged.

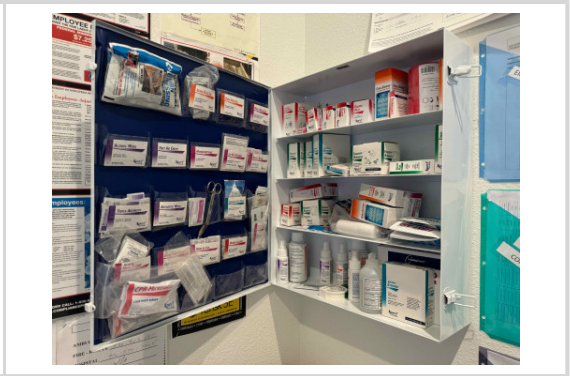
First Aid Kit(s) **Satisfactory**

First aid kit is in office.

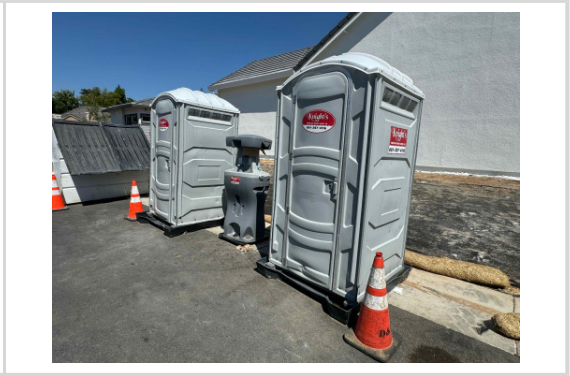
Restrooms **Satisfactory**

Restrooms are serviced regularly.

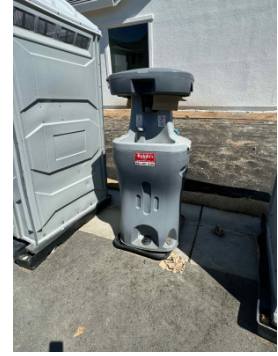
Hand Washing Stations **Satisfactory**

Wash stations are available.

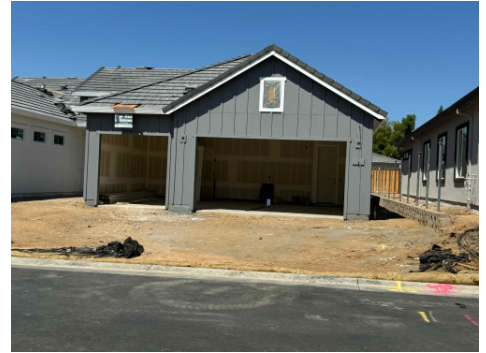
Shade is available for workers.

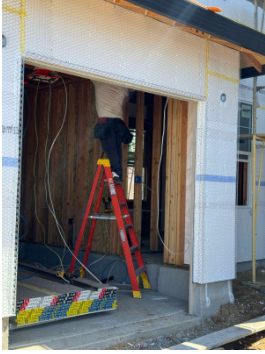
Ladders	Unsatisfactory
----------------	-----------------------

Comment	
Worker is standing on second to last rung on a-frame ladder. Asked worker not to stand on last rung to top of ladder. Corrected immediately.

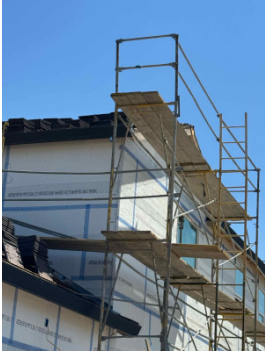
Supported Scaffolding	Unsatisfactory
------------------------------	-----------------------

- 1) Lot 36: Scaffold at roof presents a fall hazard at the end of the scaffold and roof. Guardrails are needed on the inside of the scaffold.
- 2) Lot 36: Scaffold erected inside home needs guard rails at second level and has to single planks used for access at second floor level. Planks need to be removed and not used, as it is not adequate to protect from falls.
- 3) Worker is standing on second to last rung on a-frame ladder. Asked worker not to stand on last rung to top of ladder. Corrected immediately.

Comment	
Lot 36: Scaffold at roof presents a fall hazard at the end of the scaffold and roof. Guardrails are needed on the inside of the scaffold.

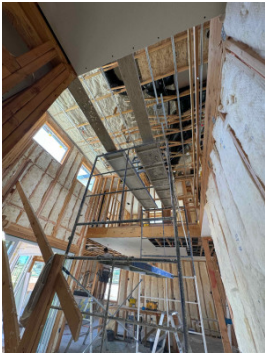
Scaffold erected inside home needs guard rails at second level and has to single planks used for access at second floor level. Planks need to be removed and not used, as it is not adequate to protect from falls.

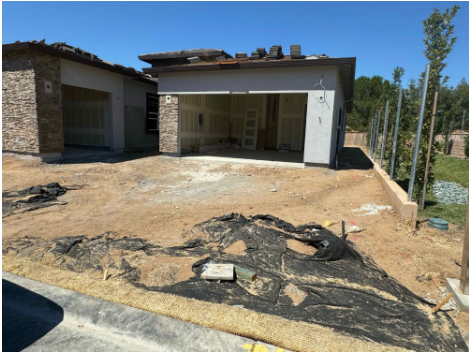
Housekeeping **Satisfactory**

Housekeeping is maintained.
