# SAFETY INSPECTION REPORT

Thomas James Homes: NorCal

1060 Karen Way Mountain View

**General Construction**

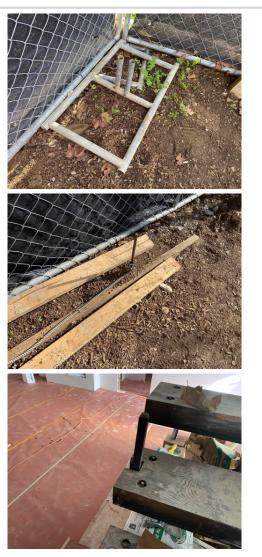
- Fence base poses an impalement hazard. Ensure it is removed from the site.
- Green stakes for orange fencing at the back of the property pose an impalement hazard.
- Posts on the stairway pose an impalement hazard.
- Note: Cal Osha mentions the following: "Protection from Reinforcing Steel and Other Similar Projections. (1) Employees working at grade or at the same surface as exposed protruding reinforcing steel or other similar projections, shall be protected against the hazard of impalement by guarding all exposed ends that extend up to 6 feet above grade or other work surface, with protective covers, or troughs.

Various hazards observed on site. See photos and summary for additional detail.
