SAFETY INSPECTION REPORT

CONDUCTED FOR:
Thomas James Homes: NorCal

PROJECT:
11 Leilani Lane Alamo

INSPECTION TYPE:
General Construction

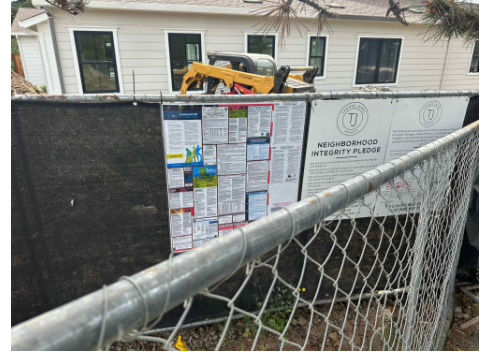
Labor Law Postings	Satisfactory
---------------------------	---------------------

Federal label poster is hung on fence.

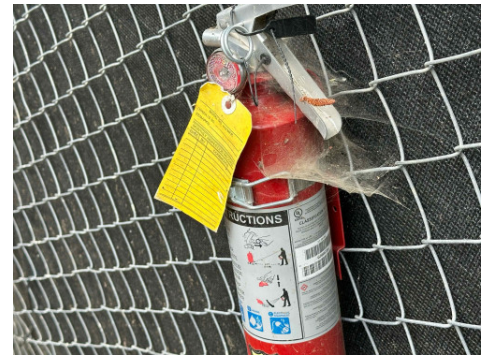
Fire Extinguisher(s)	Unsatisfactory
-----------------------------	-----------------------

Fire extinguisher was found in satisfactory condition. Extinguisher is not being inspected monthly and documented. (Justin is correcting this on the spot.)

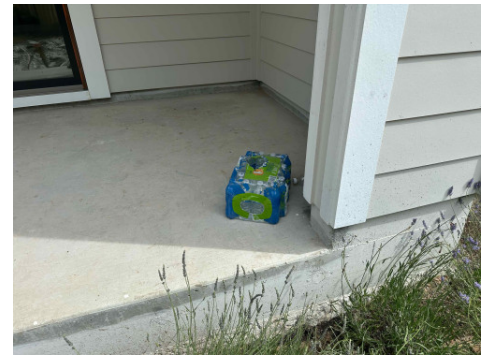
Potable Water	Satisfactory
----------------------	---------------------

Plenty of bottled drinking water was located on site.

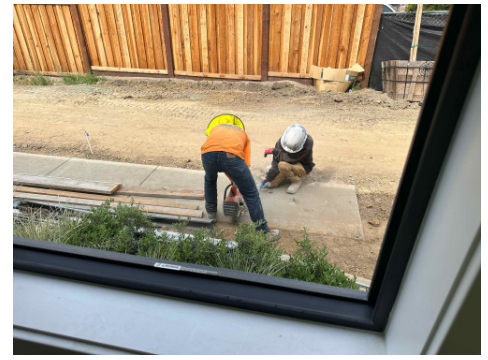
Silica Control	Satisfactory
-----------------------	---------------------

They use of water and respiratory protection while concrete cutting was being used to reduce silica exposure.

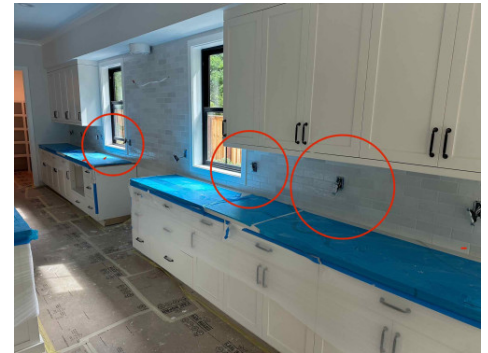
Electrical Safety

Live electrical outlets were left pulled and exposed. This presents an electrical shock hazard due to live exposed wiring.

Missing covers and free access to exposed energized electrical parts must be replaced. These dangers can easily be eliminated by replacing missing covers to electrical panels, boxes and outlet by covering the openings that have unrestricted access to exposed energized electrical parts and preventing the danger of shock and electrocution.

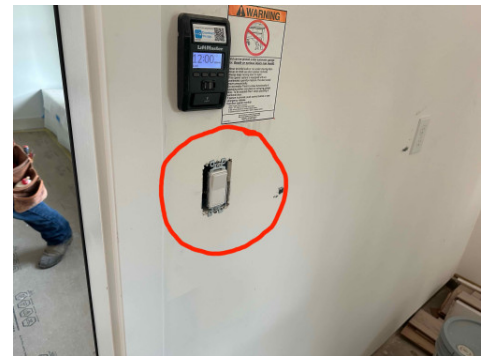
Missing outlet and light switch covers were observed. This presents an electrical shock hazard due to live exposed wiring.
