# SAFETY INSPECTION REPORT

Thomas James Homes: NorCal

119 Brook Street BOY San Carlos

General Construction

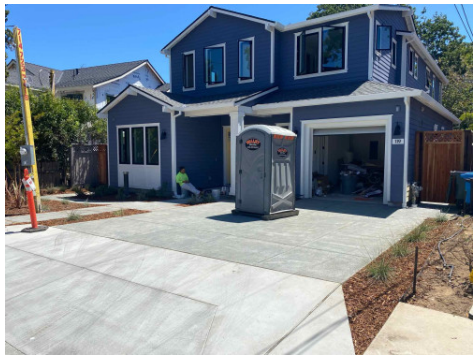
<b>Access / Egress</b>	<b>Satisfactory</b>
------------------------	---------------------

Comment	
Good access is in place for the site.

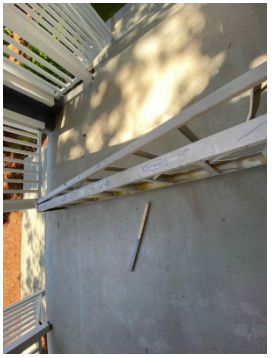
<b>Ladders</b>	<b>Unsatisfactory</b>
----------------	-----------------------

- Ladders missing legible safety and proper use labels. Note: A designated competent person can inspect the ladder and attach new stickers after they do an inspection to ensure the ladder is still in good condition and safe for use. Then employees can be made aware the ladder is safe to use.

<b>Comment</b>	
Ladder belonging to JW Peterson missing legible safety labels. See summary for additional details.	 
Additional ladder missing legible, safety labels.

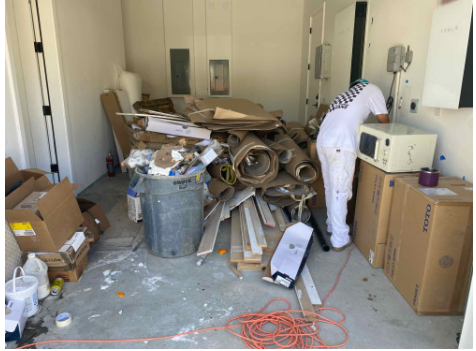
<b>Housekeeping</b>	<b>Unsatisfactory</b>
---------------------	-----------------------

- A sizable amount of debris and materials are building up in the garage. It is recommended these items be removed. This poses a trip hazard for those accessing the garage.

<b>Comment</b>	
<p>There is a buildup of garbage and materials in the garage. This is a trip hazard and should be removed.</p>

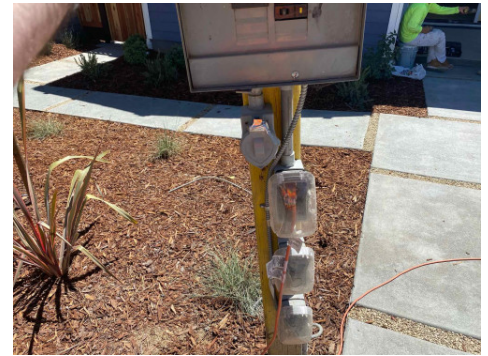
<b>Electrical Safety</b>	<b>Satisfactory</b>
--------------------------	---------------------

No concerns observed. Good job having all covers in place!

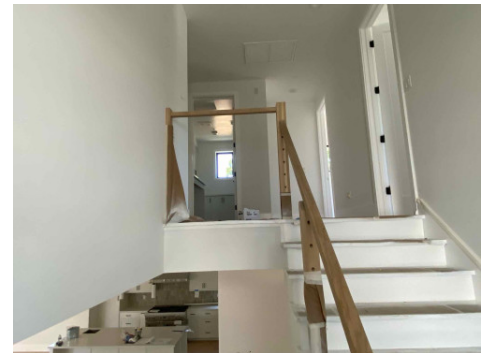
<b>Stairways, Ramps, Runways</b>	<b>Unsatisfactory</b>
----------------------------------	-----------------------

- Toe-boards missing from the top of the stairway. Toe-boards protect tools and materials from potentially falling below and striking someone. A standard toeboard shall be 4 inches (nominal) minimum in vertical height from its top edge to the level of the floor, platform, runway, or ramp. It shall be securely fastened in place and have not more than 1/4-inch clearance above floor level.

- Mid-rail missing on stairway and second floor. Ensure a mid-rail or equivalent is in place to avoid fall hazards. The mid-rail should be midway between the floor and top rail and have the ability to support 150 lbs of force. Sub-contractors ensure the stairway is left in a safe condition.

Stairway and second floor by stairway missing a mid rail and toe-board. See summary page for additional comments.

- As a reminder: Guardrails should consist of a wooden top rail that is 42 inches to 45 inches high and that measures 2 inches x 4 inches or larger. A mid-rail shall be placed halfway between the top rail and the floor.
