SAFETY INSPECTION REPORT

CONDUCTED FOR:
Thomas James Homes: NorCal

PROJECT:
127 Wildwood Avenue San Carlos

INSPECTION TYPE:
General Construction

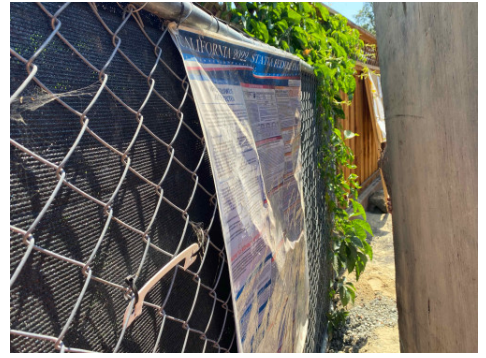
Labor Law Postings Unsatisfactory

- Labor law posters are from 2022. 2024 labor laws need to be posted.

Posted labor laws are from 2022.

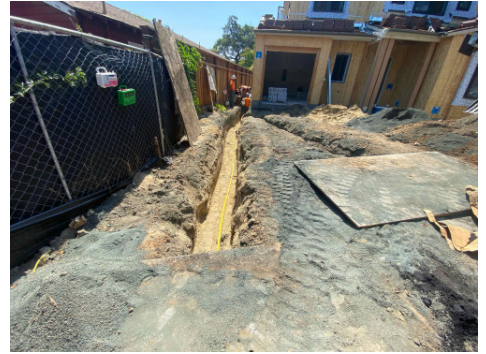
Access / Egress

Good access and egress is in place. Sub was working, actively in the trenches, but was prepared to make sure they were safe by the end of the day.

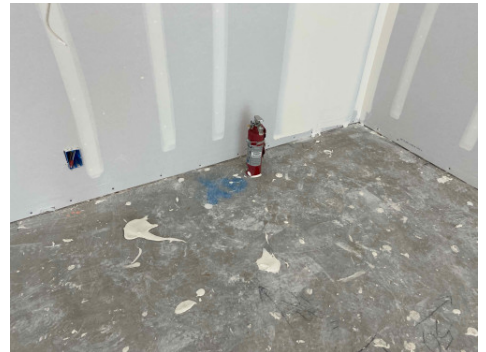
Fire Extinguisher(s)

On site in the house. Note: extinguisher could not be found up on the fence.

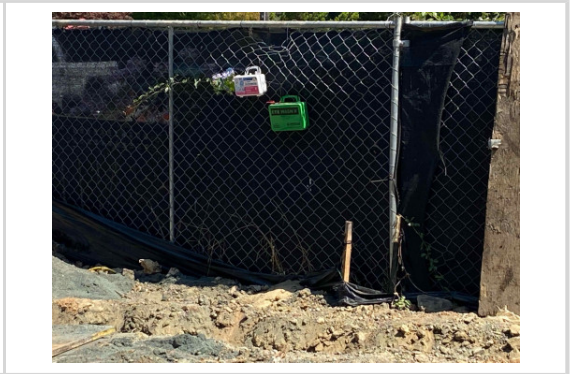
First Aid Kit(s)	Satisfactory
-------------------------	---------------------

Good job having this up on the fence.

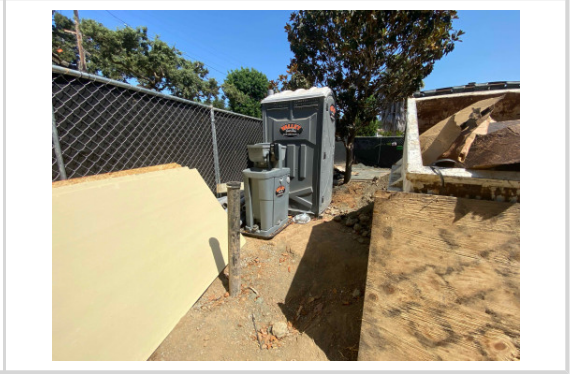
Hand Washing Stations	Satisfactory
------------------------------	---------------------

Good job having proper hand wash facilities in place.

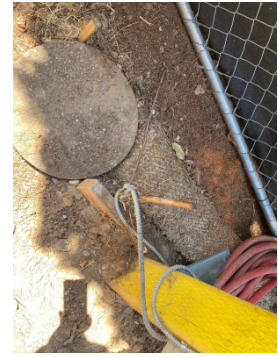
Impalement Hazards **Unsatisfactory**

- Grounding stakes for the temp electrical panel pose an impalement hazard.

Grounding stakes for the temp electrical panel are hazard. See summary for additional details.

Note: Cal Osha mentions the following: "Protection from Reinforcing Steel and Other Similar Projections. (1) Employees working at grade or at the same surface as exposed protruding reinforcing steel or other similar projections, shall be protected against the hazard of impalement by guarding all exposed ends that extend up to 6 feet above grade or other work surface, with protective covers, or troughs.

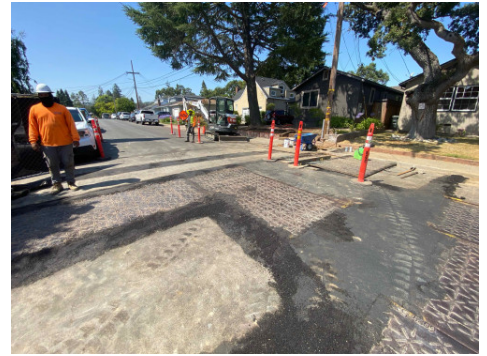
Traffic Control

Good job by Kavanagh having this in place.

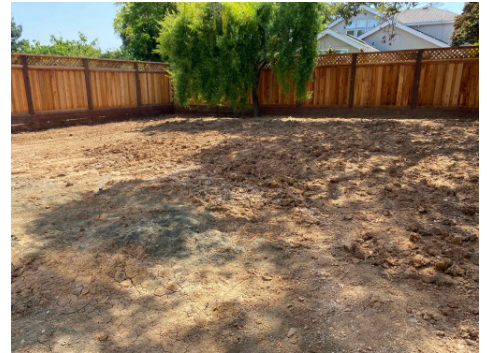
Housekeeping

Back of sight is very neat and clean.

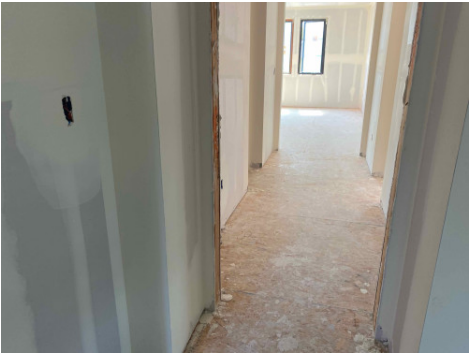
<p>Inside is clean.</p>

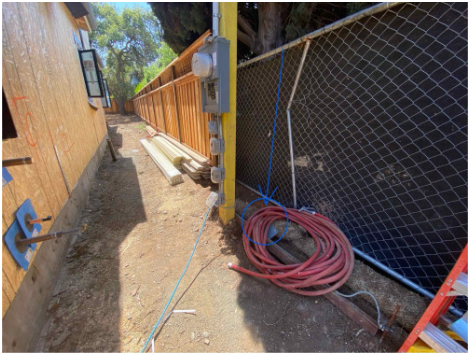
<p>Electrical Safety</p>	<p>Unsatisfactory</p>
---------------------------------	------------------------------

- Temp panel cover has fallen to the ground. Replace it as soon as possible. This is a shock hazard for anyone using the temp power pole.

<p>Comment</p>	
<p>Temp electrical panel cover has fallen into the ground. Ensure this is replaced immediately.</p>

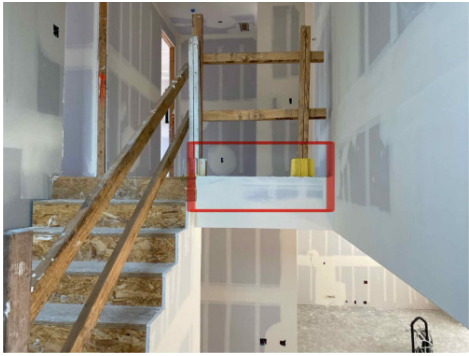
<p>Stairways, Ramps, Runways</p>	<p>Unsatisfactory</p>
---	------------------------------

- Toe-boards missing from the top of the stairway. Toe-boards protect tools and materials from potentially falling below and striking someone. A standard toeboard shall be 4 inches (nominal) minimum in vertical height from its top edge to the level of the floor, platform, runway, or ramp. It shall be securely fastened in place and have not more than 1/4-inch clearance above floor level.

Toe board is missing.
