SAFETY INSPECTION REPORT

CONDUCTED FOR:
Thomas James Homes: NorCal

PROJECT:
1371 Sherman Ave Menlo Park

INSPECTION TYPE:
General Construction

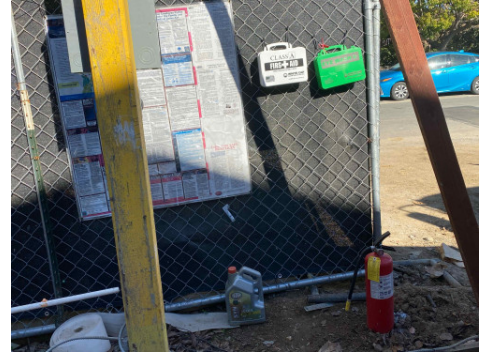
Labor Law Postings Satisfactory

Good job having these posted.

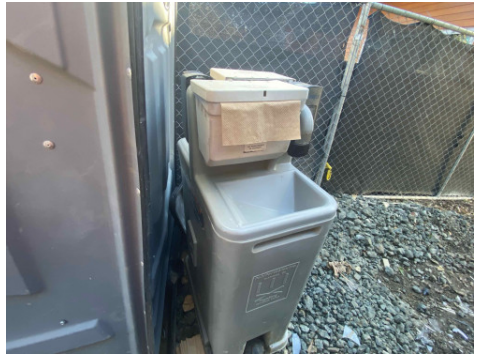
Hand Washing Stations	Satisfactory
Comment	-
Wash stations are clean and in sanitary condition. There is an adequate supply of soap and paper towels.

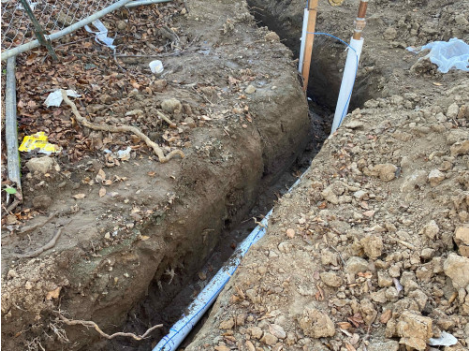
Trenching & Excavation	Unsatisfactory
-----------------------------------	-----------------------

- Unmarked trench that poses a trip or fall hazard to workers. A delineation line or cover should be used to protect workers in the area from the hazard.

Comment	Cloverleaf
Delineation lines missing from around this trench. Ensure that the lines or covers are put in place.

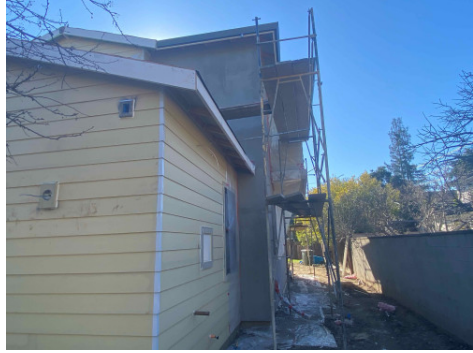
Supported Scaffolding	Unsatisfactory
------------------------------	-----------------------

- All scaffolding on site must be red-tagged as "Do Not Use" and no one should be allowed to use it until it is made safe by a qualified erector and a competent person signs off on it.
- A green tag/red tag system is recommended where the competent person inspects the scaffold daily and signs off when it is safe to use.
- On a 3 foot wide scaffolding an anchor is needed starting at 9 feet high and every 20 feet vertically. Additionally anchors must be within 12 feet of the top of the scaffold. Anchors should be at least every 30 feet horizontally. Ensure end frames are properly anchored.
- Pins are not installed going through the scaffolding frame.
- Some areas are missing the straight brace and/or X-braces on exterior frame.
- Mud-sills need nails.

Comment	Benicia
<p>Various issues with supported scaffold on site.</p> <ul style="list-style-type: none"> - Safe access missing. - Straight real missing from inside of scaffold. - Pins missing from scaffold. - anchor points missing from scaffold. -Proper mud seal installation missing. <p>Ensure the subcontractor has confident persons in charge of erection and inspection of scaffolding. All scaffolding should be Red tagged and not used until issues can be fixed.</p>

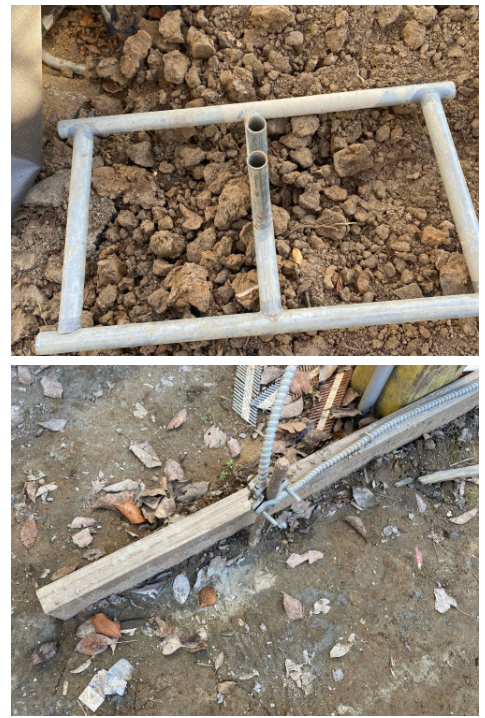
Impalement Hazards	Unsatisfactory
---------------------------	-----------------------

- Fence base poses an impalement hazard. Ensure it is removed from the site.
- Electrical grounding stakes by the temp electrical panel pose an impalement hazard.
- Note: Cal Osha mentions the following: "Protection from Reinforcing Steel and Other Similar Projections. (1) Employees working at grade or at the same surface as exposed protruding reinforcing steel or other similar projections, shall be protected against the hazard of impalement by guarding all exposed ends that extend up to 6 feet above grade or other work surface, with protective covers, or troughs.

Hazards exist on site. See photos and summary for additional detail details.

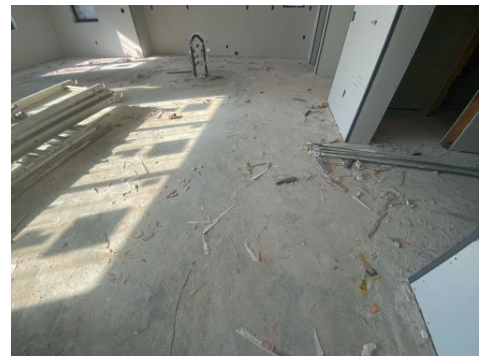
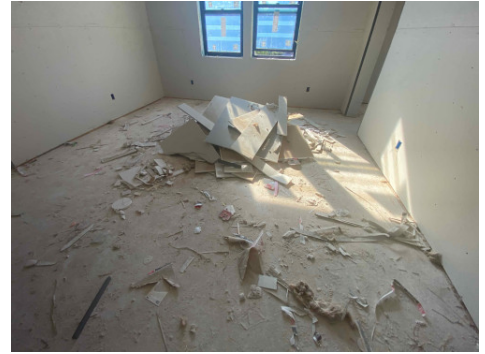
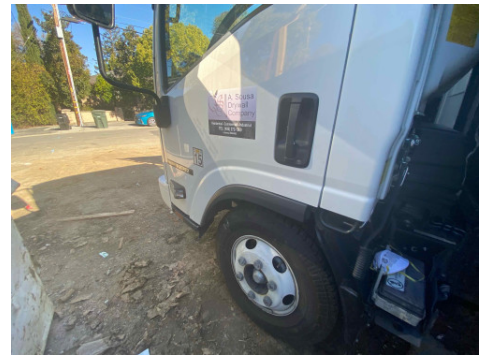
Housekeeping	Satisfactory
---------------------	---------------------

The site needs improved housekeeping for drywall materials. However, the drywall contractor was on site actively performing cleaning. For that reason this item is left satisfactory. See photos for additional details.

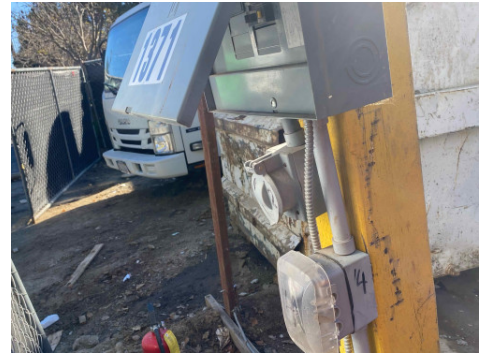
Electrical Safety	Satisfactory
--------------------------	---------------------

No concerns observed.

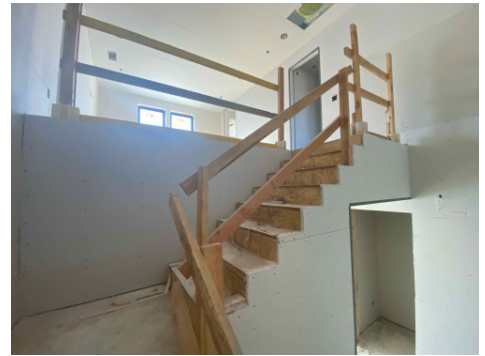
Stairways, Ramps, Runways

Good job having toe boards in place.
